Bhutan Water Partnership

Assessment Report

Effluent Discharge and Management by Automobile Workshops in Paro Municipal Area; Bhutan

November, 2017

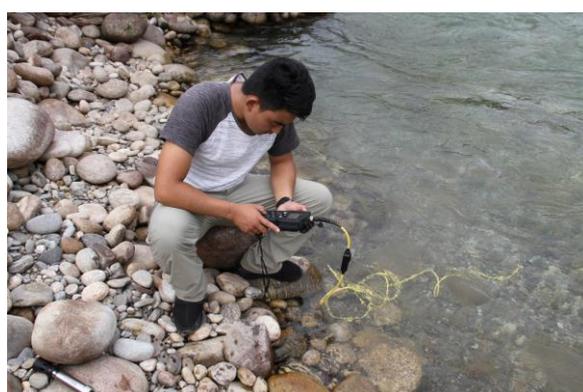
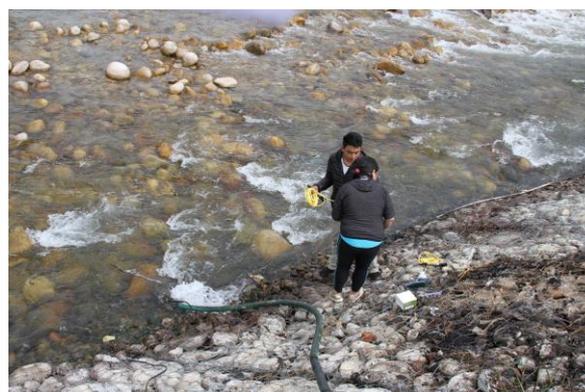
The physical measurement results from all the sampling sites are presented in table 1 to 3. The results showed that all the parameters were within the NEC's maximum recommended limit as reflected in ambient water quality criteria and industrial effluent discharge standards, 2010. The pH of the water was slightly alkaline in all the sampling sites as its pH values were higher than 7 (neutral) ranged from 8-8.29.

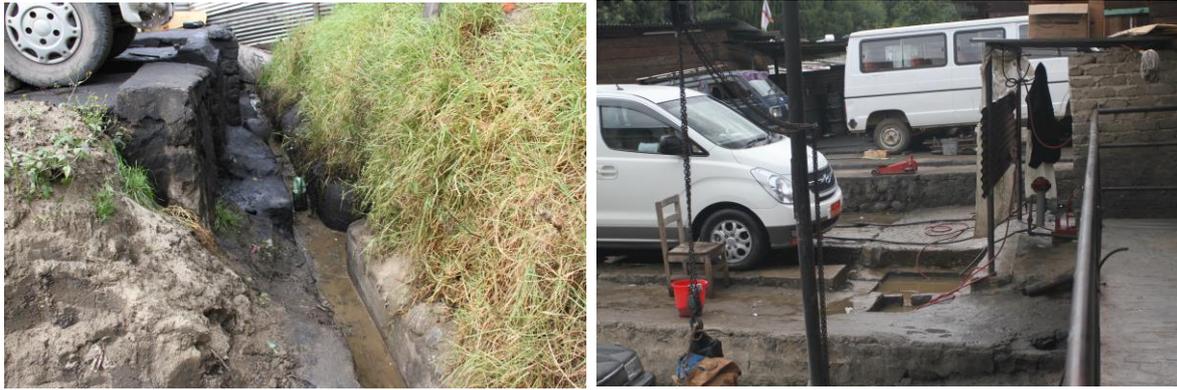
Although, during the focus group discussion and also questionnaire interview, it was reported that the engine oil is collected in a large container and sold to the neighboring country, there are evidences of spillage of these oil on the ground. It is assumed that most of the spillage flow out in to the water bodies or contaminates the soil.
