# Identified Barrier #2 to climate-resilient water management in Tanzania

Inefficient irrigation water uses and practices: the  
case of Ruvu Sub-Basin

**A root cause analysis**

November 2023

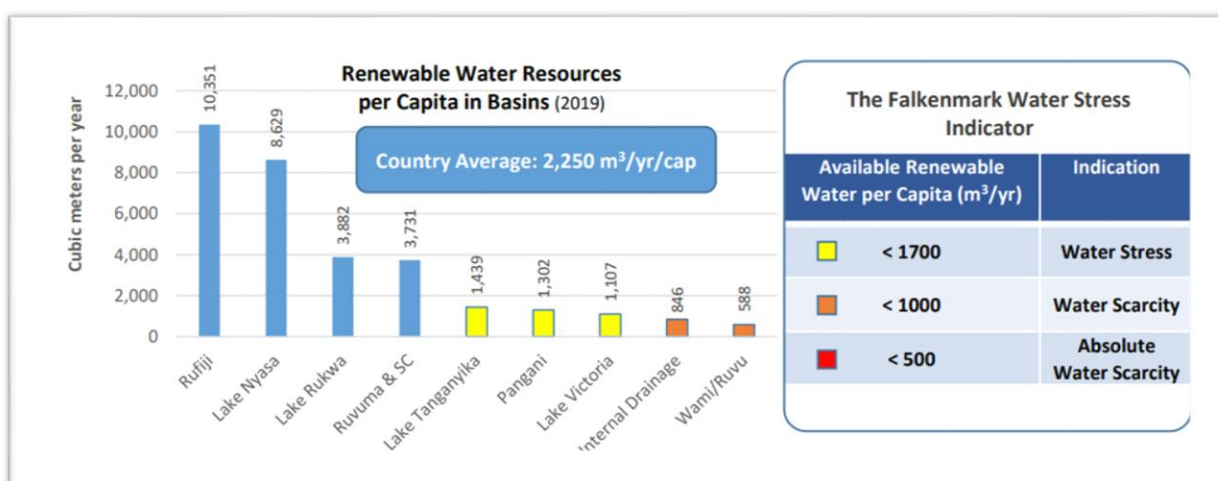
Figure 1.3. The status of water resources in the basins of Tanzania basins expressed as per capita water availability in m<sup>3</sup>/year (Source: Tanzania Water Resources Atlas, 2019)

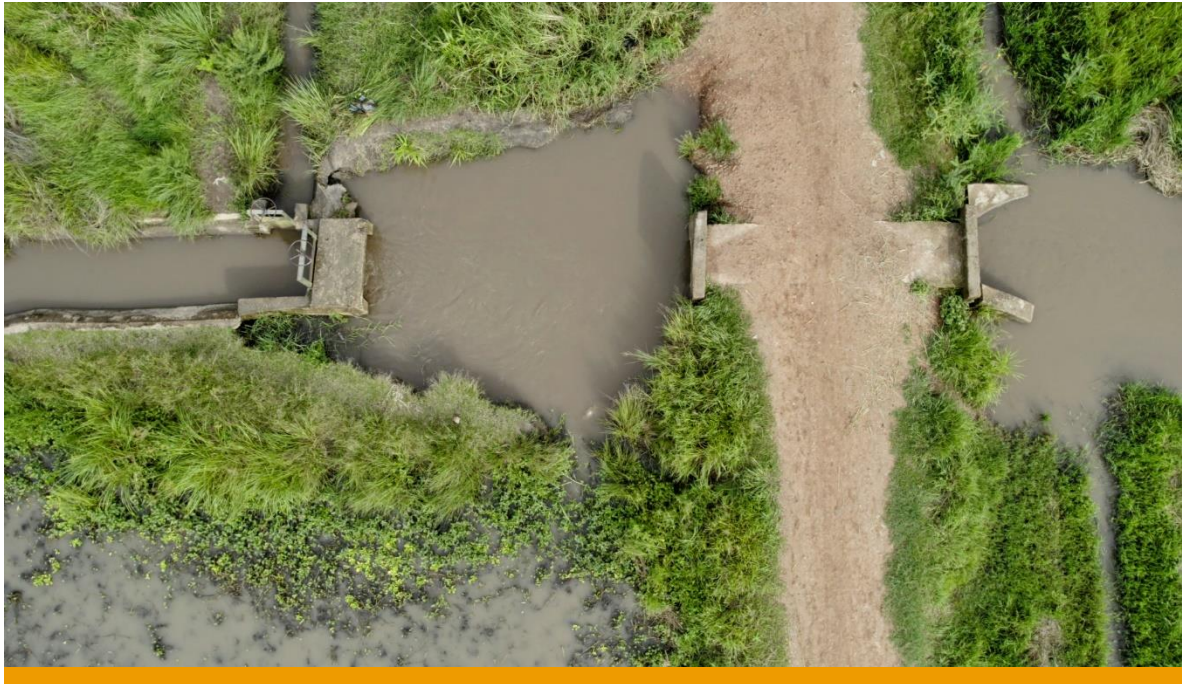
An aerial view of the Tulo Kongwa Irrigation system. The system is unlined, a sign of inefficiency.

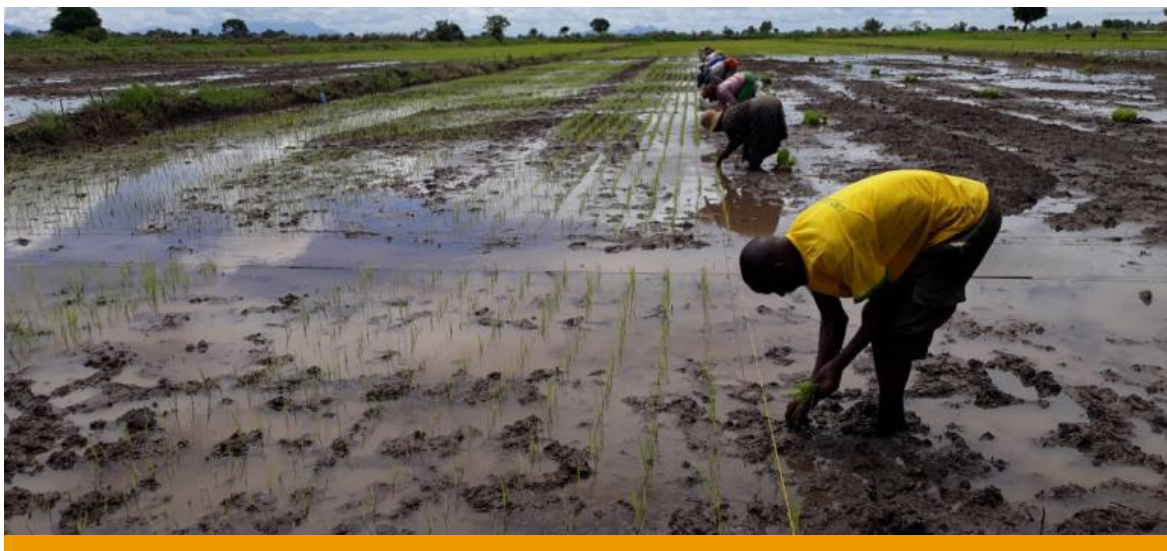
Figure 2.1. Flood irrigation practiced in the Upper Ruvu catchment

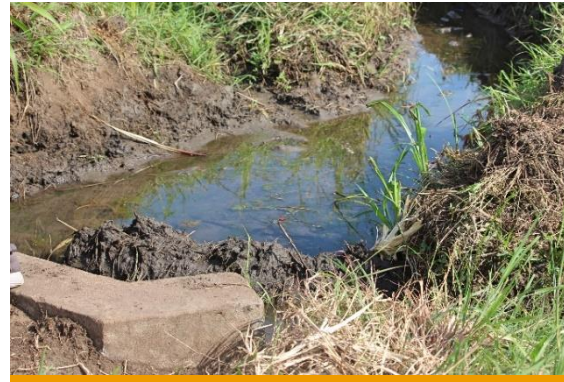
Figure 3.3. Conveyance outlet to farms

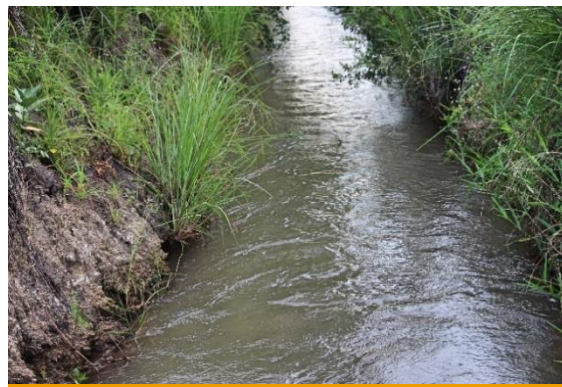
Figure 3.5. Conveyance canals at the lower end

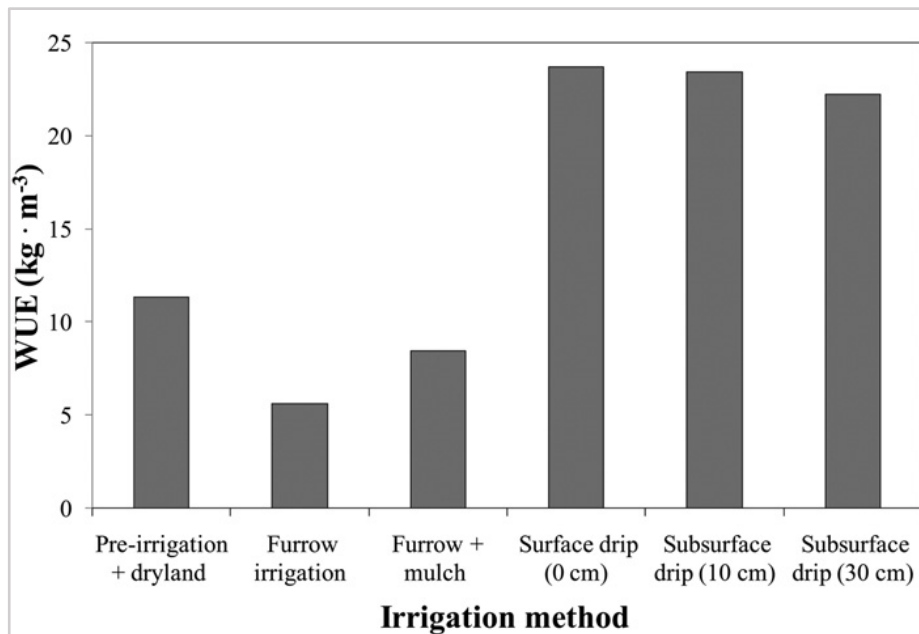
Figure 3.6. Water-use efficiency (WUE) of different irrigation methods

Observation made during field visit to the irrigation schemes indicated that furrow surface irrigation coupled with lined and unlined canals are being used in the Upper Ruvu catchment. It was noted that both Mbalangwe and Tulo Kongwa irrigation schemes are utilizing surface irrigation techniques where water flows over the soil surface by gravity, either by flooding or in furrows. This technique is proved inefficient in terms of irrigation inefficiency; application inefficiency (uneven/excessive application depths). The irrigation inefficiency, which affects water use efficiency, was found to be low, with literature indicating that furrow irrigation has a low water use efficiency of 5 to 10 Kg/m<sup>3</sup>, as seen in Figure 3.6. Additionally, the potential application efficiencies

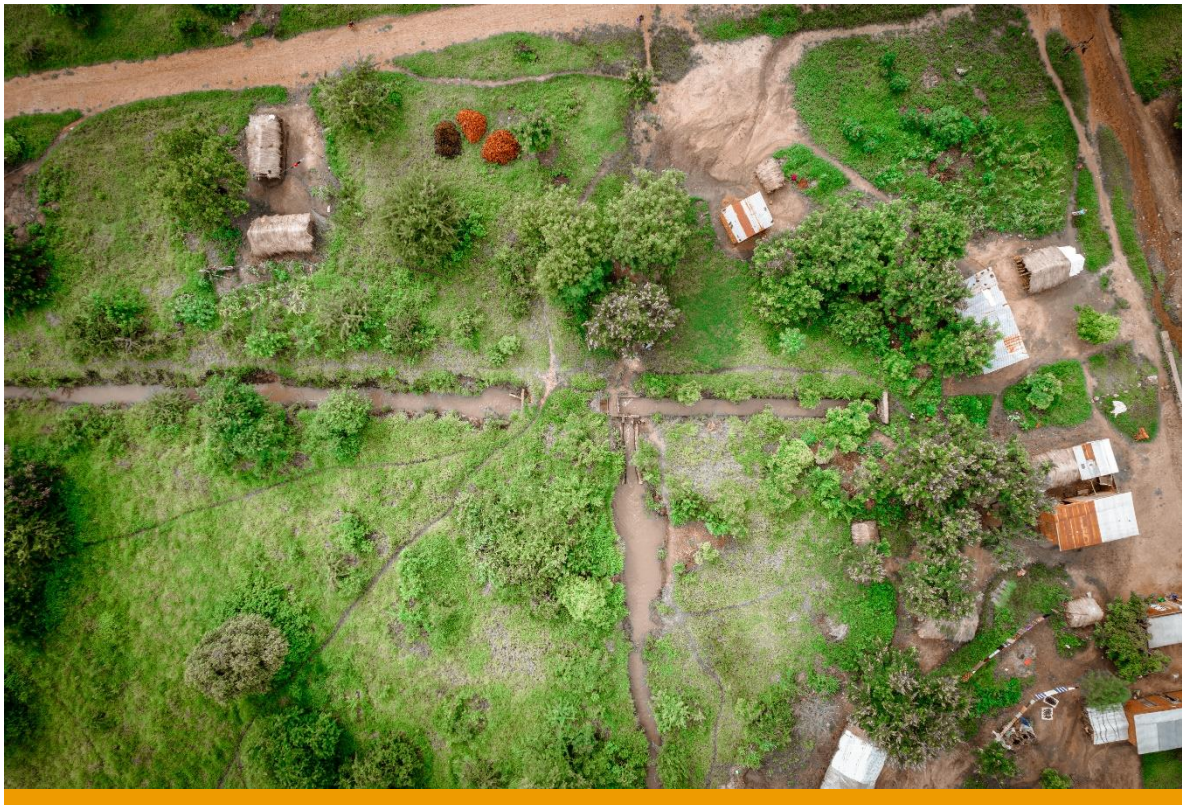
An aerial view of a different section of the Tulo Kongwa irrigation scheme. This section is also unlined.

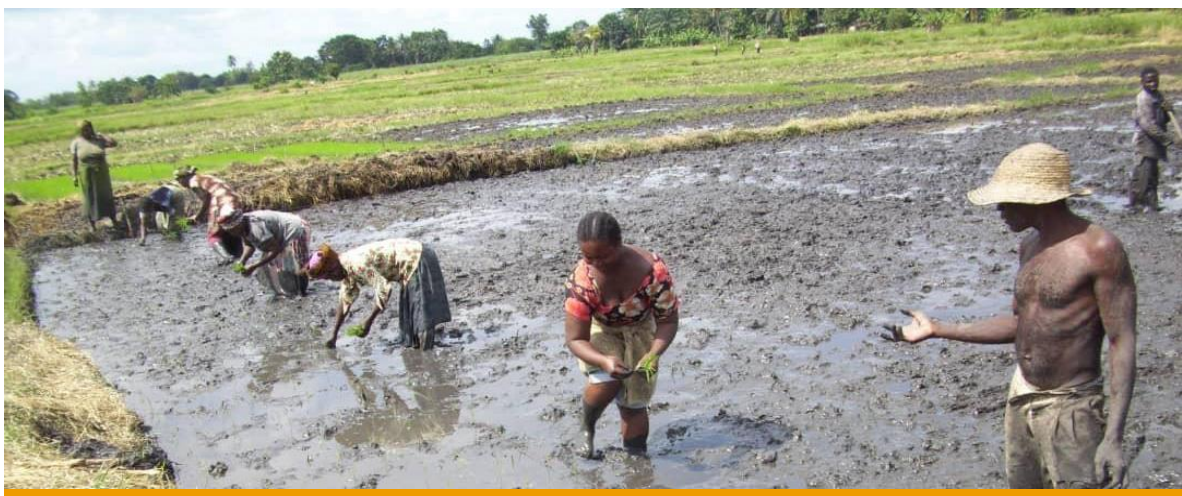
Farmers in the Kilombero Valley, part of the Rufiji river basin, practicing the System of Rice Intensification (SRI), an agricultural methodology that is being promoted to increase efficiency and productivity.

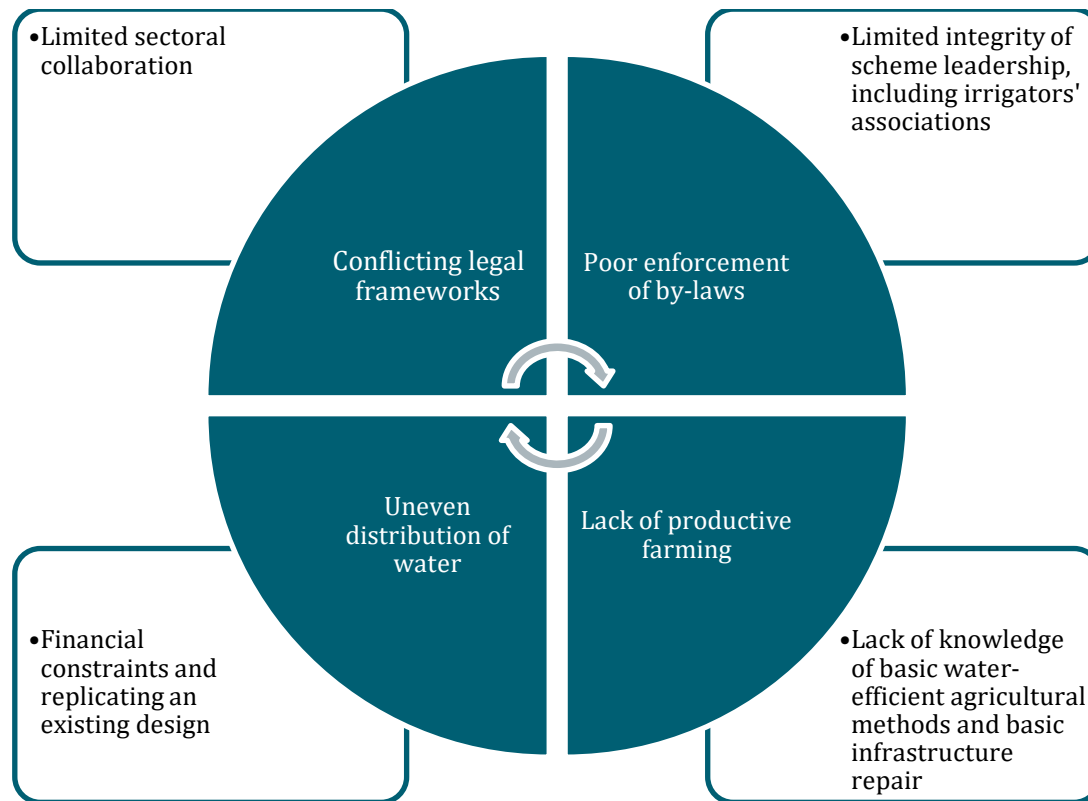
Figure 4.1. A summary of root causes of irrigation inefficiency in the Upper Ruvu catchment

This short study identified four major root causes of irrigation inefficiency, considered in different ways presented in Table 4.1 and Figure 4.1. and discussed in more depth below.
