NATURAL SMALL WATER RETENTION MEASURES

– CASE STUDIES –

Global Water Partnership Central and Eastern Europe (2015). Natural small water retention measures. Case Studies, Global Water Partnership Central and Eastern Europe

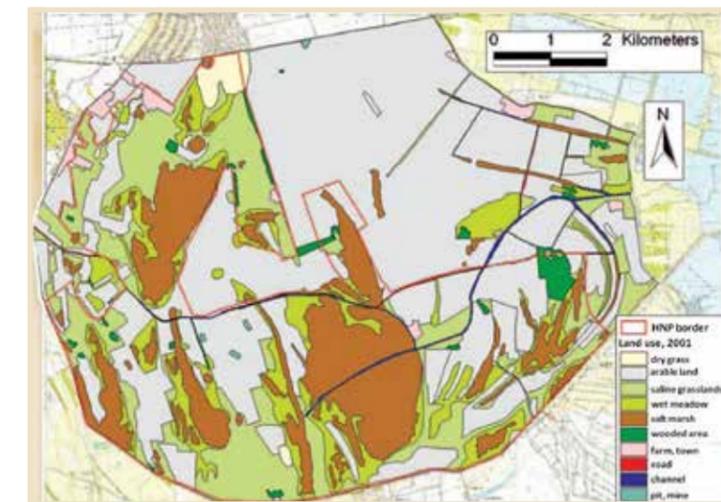
Fig. 2. The hydrological reconstruction has caused the rapid regeneration of the marshes, with their areal extent increasing to 26-28% (habitat map from 2001)

The habitat-level changes following the hydrological reconstruction have caused a regeneration and revitalisation of the marsh habitats. In a few years, the areal extent of marshes has approached the level estimated before human activities had started to transform the area (Fig. 2). Today the marsh system is characterised by a mosaic-like landscape structure, the most important elements of which are the ancient riverbeds running mostly from N to S, the loess covered higher grounds between the marshes, the meadows in the edges of marshes, the alkali grasslands and pastures, and the small pockets of woodlands, tree lines and dry loess grassland fragments.

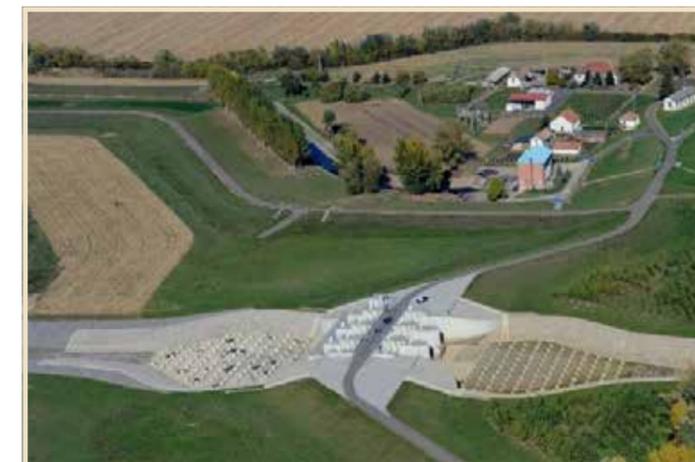
Photo 1. Area photo of the intake structure of the Cigánd Flood Mitigation Reservoir © (photo: H. Szabó Sándor)

In accordance with the VTT, a flood mitigation reservoir was built at Cigánd, the first one of the 14 planned reservoirs. The work on the reservoir began in 2005, and it was completed and put in operation in 2009 (Fig. 3 and Photo 1).

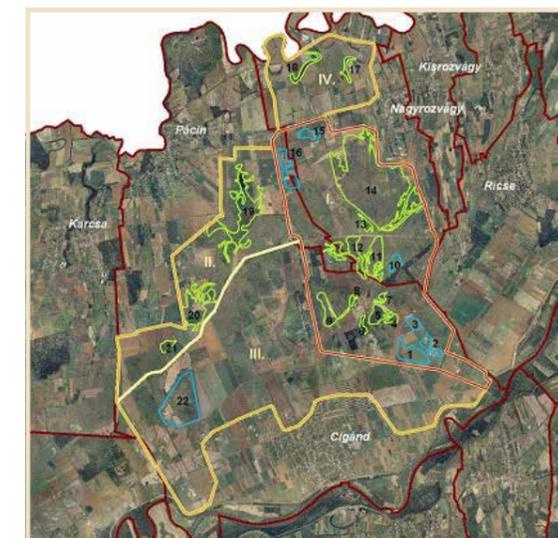
Fig. 4. Aerial photo of the Cigánd Flood Mitigation reservoir (I.) and the related land management zones (II-IV.) (Note: Blue line - area with planned permanent water surface; green line – area suitable for temporal small water retention)

- Cigánd the reservoir (Zone I. delineated with orange line)
- A former land management pilot area, which is situated to the west of the reservoir (Zone II)
- The area between the reservoir and the spillway, including the reservoir itself (Zone III landscape management component.)
- The territories north of the reservoir (Zone IV landscape management component)

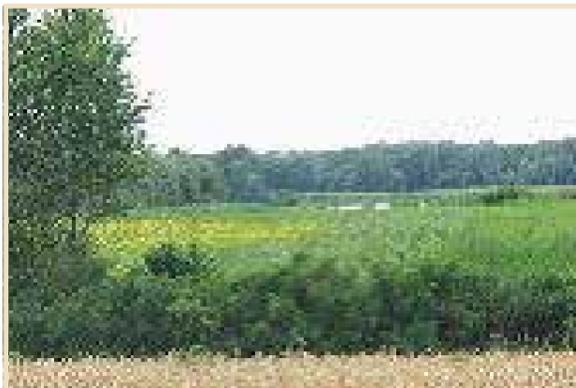
Photo 2. Improved landscape within the reservoir

The reservoir and the related engineering structures that serve water retention and water diverting purposes, enhance the vegetation cover in accordance with the local circumstances (Photos 2 and 3).

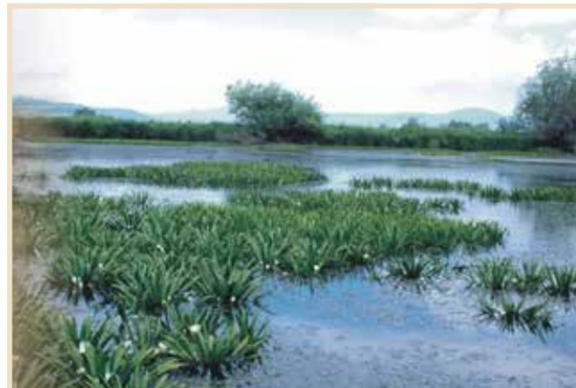
Photo 3. Increased water retention in the area

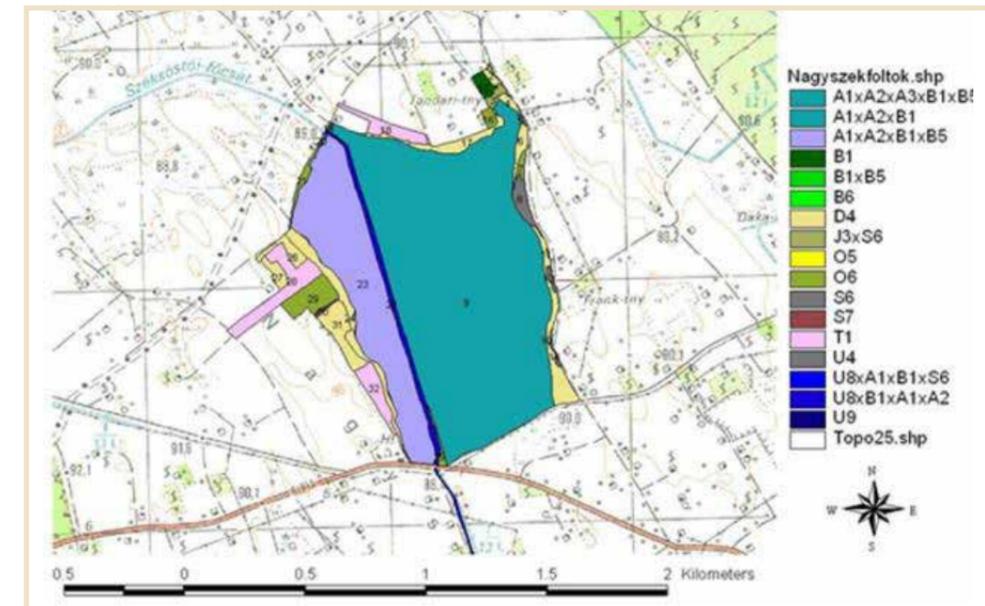
Fig. 5. Habitat types at the Nagyszéksós Lake

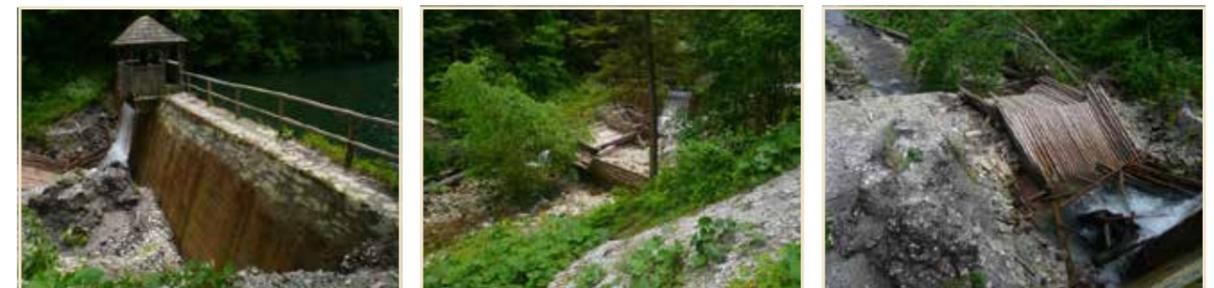
Photo 6. The Weir HB Klauzy after passing flood wave 2010 (photo by Mosný)

Photo 6 illustrates the condition weir before reconstruction.

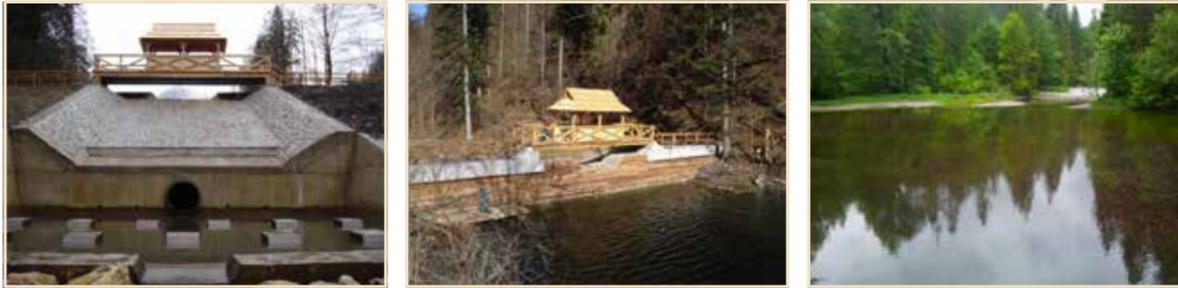
Photo 7. The Reconstructed mountain weir HB Klauzy 2014 (photo by Fodor, State Enterprise)

Photo 7 illustrated the condition after reconstruction.

The benefits of the reconstruction include to rescuing historic mountain wear for destruction due to floods, restoring and enhancing retention capacity of the reservoir, and improving their flood transformational abilities. The improved water retention capacity also improve the conditions for flora and fauna in the basin. The area will also be used for fishing, recreation and tourism.

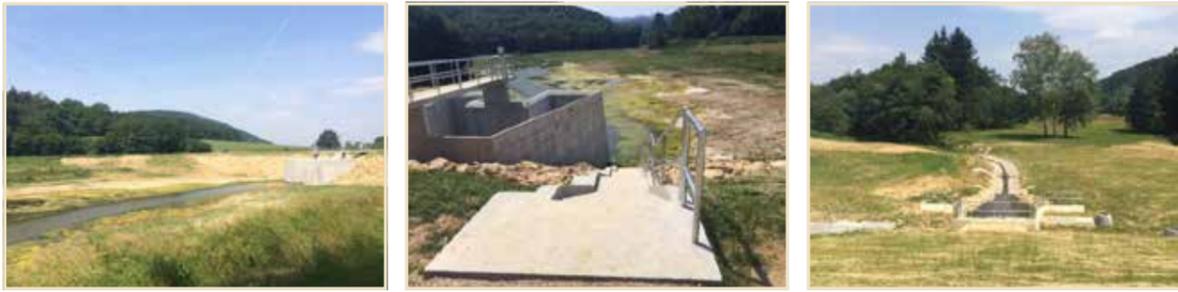
Photo 8. The Polder on the River 2014 (photo: Slovak Water Management Enterprise)

The next photo illustrates the construction of the polder and the reconstruction of the river Hradsky potok.

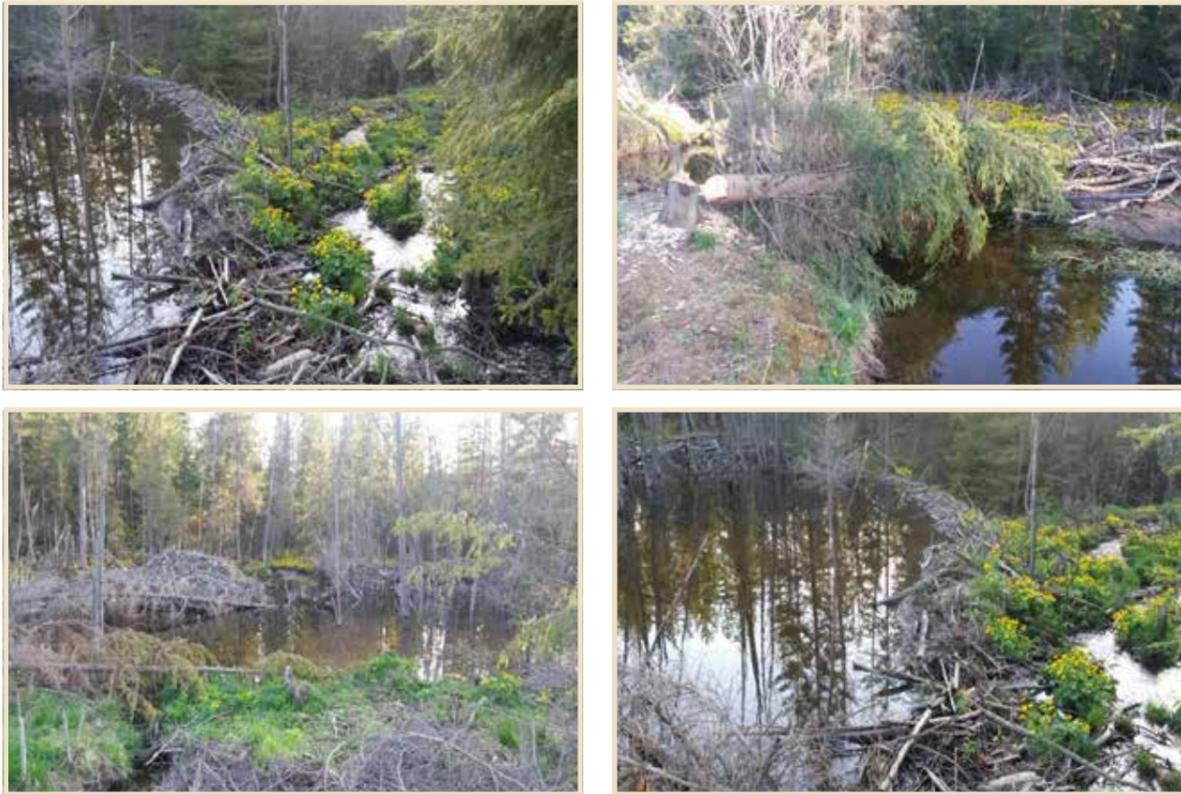
Photo 9. The Natural water measures in basin Javorinka 2014 (photo by Mosny)

The beavers weirs restore and enhance retention water capacity. The improved water retention improve the conditions of flora and fauna in the basin (Photo 9).

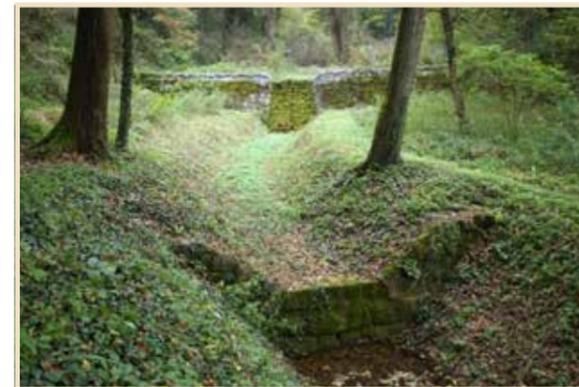
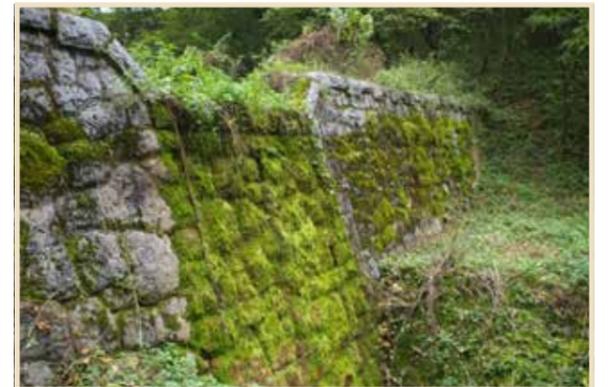
Photo 11. Lower part of the Haluzice Gorge with 4 m high stone weir

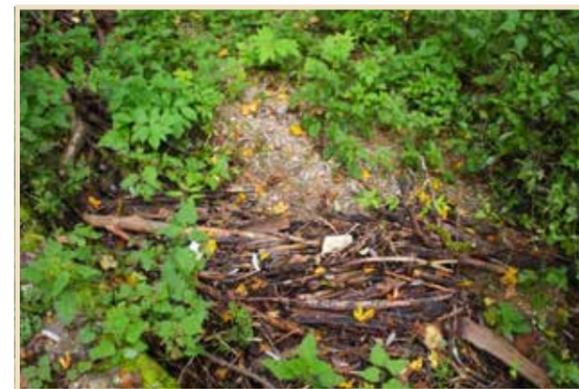
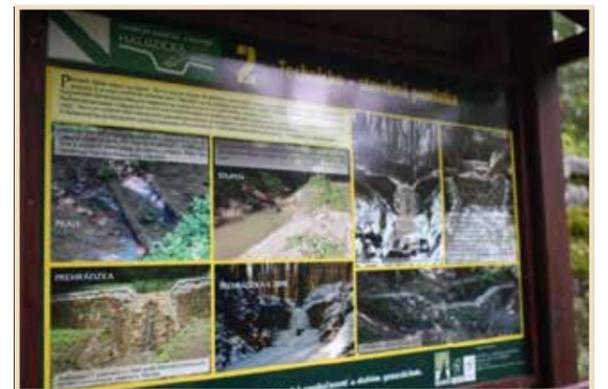
Photo 12. Woody debris retained by the stone weir in the lower part of the Gorge and information panel of the significant forest trail

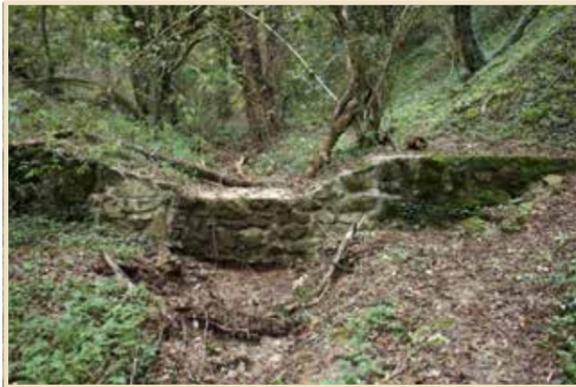
Photo 13. Middle part of the Gorge with stone weir and woody sill to reduce water flow

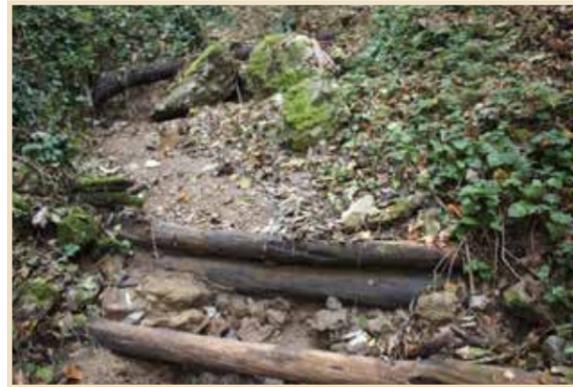
Photo 14. Middle part of the Gorge with woody sill to reduce water flow and lush vegetation

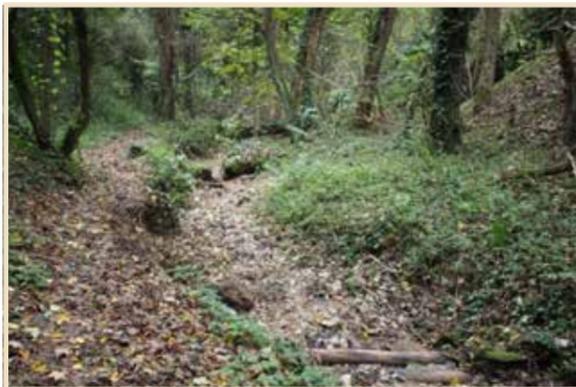
Photo 15. Upper part of the gorge with two stone weirs

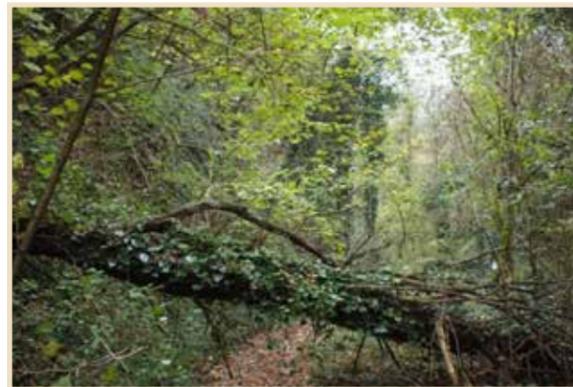
Photo 16. Side valley of the gorge with two stone weirs
Photos: Richard Muller

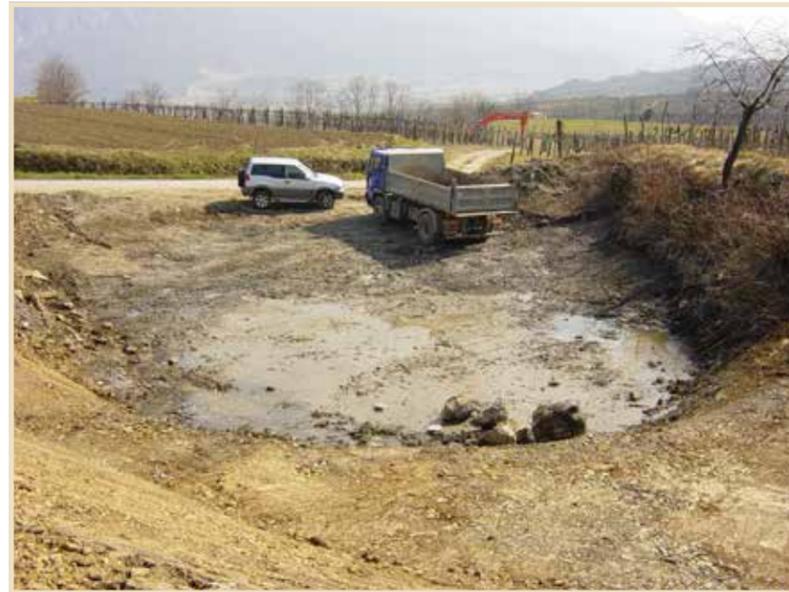
Photo 18. Restoration of karst pond (photo by: Igor Maher)

The preparation for the restoration of the karst pond in Goče started early in 2005. The first step was to prepare a plan, make an inventory of flora and fauna, and have consultations with local people and conservationists. The restoration began in March 2005. First, the karst pond was cleared from garbage and some vegetation. Next, trucks squashed the clay to retain water (Photo 18). The area was also made flat to make it easier to restore vegetation. The karst pond was then filled with water, and drainage was built to regulate excessive water.

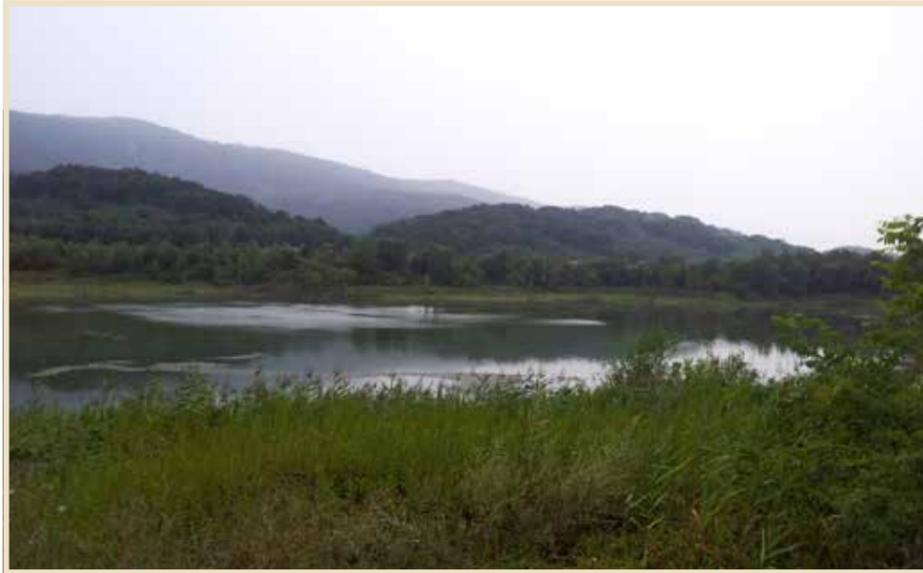
Photo 19. Clay pit in phase of rehabilitation (photo by: Anja Potokar)

The restoration process has been conducted with the aim to minimise the environmental impact. Initially, soil excavated from clay pit was used on site for construction of embankments for flood protection. Until the restoration is completed, the biotope is maintained artificially by pumping water at a suitable elevation (Photo 19).

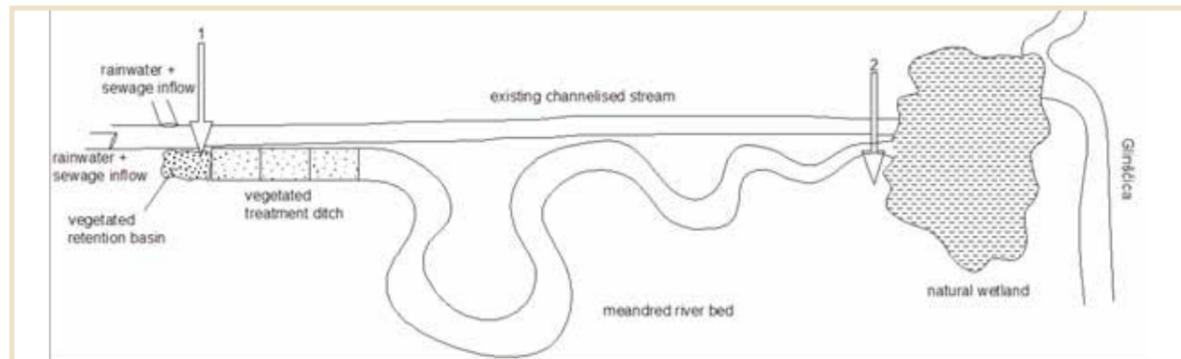
Fig. 12. A scheme of the implemented phytoremediation system

The mixed inflow water (tributary stream, storm water runoff and sewage) flows through a vegetated sedimentation basin into three compartments of vegetated treatment ditch, filled with gravel mixture and planted predominately with *Phragmites australis*. From the ditch, the treated water flows into a meandered stream and continues into a natural wetland.

The multifunctional phytoremediation system is composed of several segments with different functions. The first segment is a wastewater treatment segment. These are composed of a vegetated retention basin (VRB) and a vegetated treatment ditch (VTD), with the function of retention and filtration of suspended solids, adsorption, and aerobic and anaerobic degradation of organic matter and assimilation of nutrients into the plant biomass. The second segment is a meandered and more dynamic riverbed, with the function of prolonged water flow for longer water retention and purification capacity, and better aeration of water for better purification. Furthermore, assimilation of nutrients into the plant biomass is enhanced, resulting in an increase of microhabitats, providing an improved stability to the ecosystem.

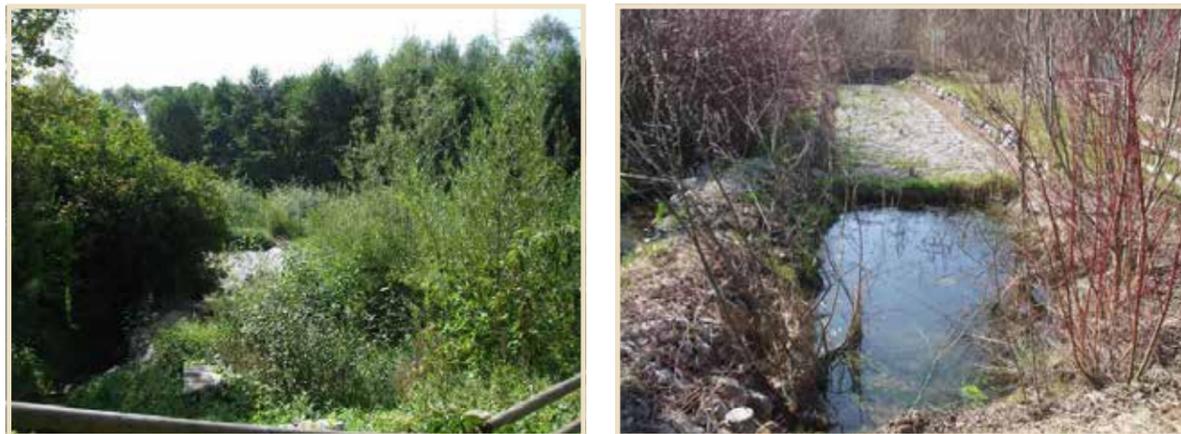
Photo 20. Left- Multifunctional phytoremediation system in the summer of 2011; Right- Multifunctional phytoremediation system in the spring of 2013, after a long winter, before beginning of plant growth

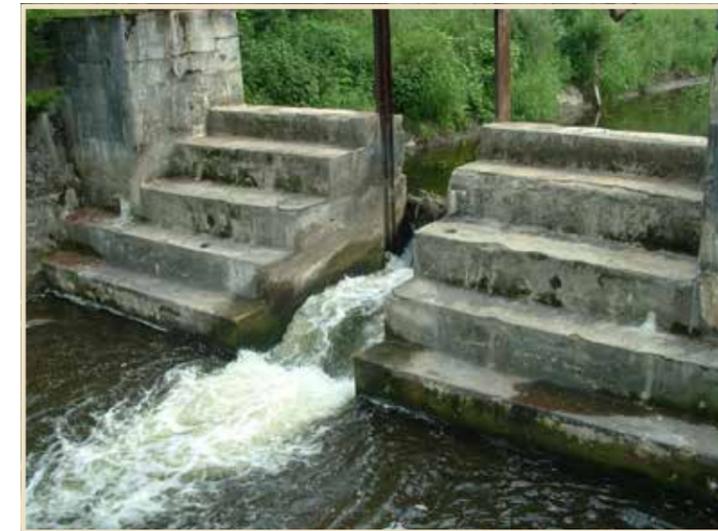
Photo 21. Damming device on the channel constructed in the 1920s

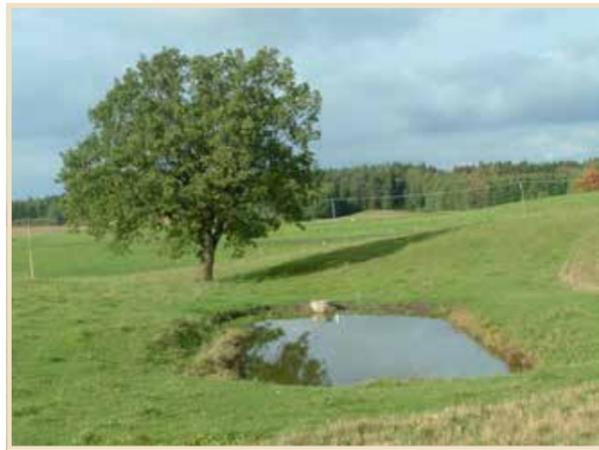
Photo 23. Pond supplied by drainage waters

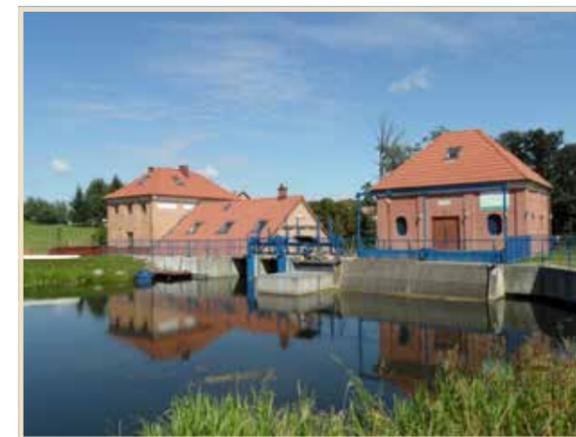
Photo 24. Water reservoir with small power plant

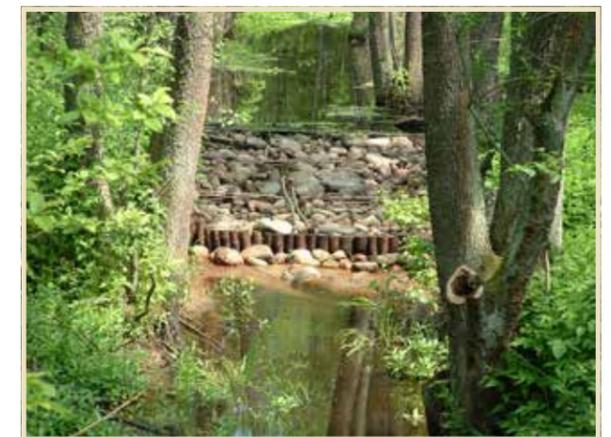
Photo 25. Stone threshold – small retention in forests

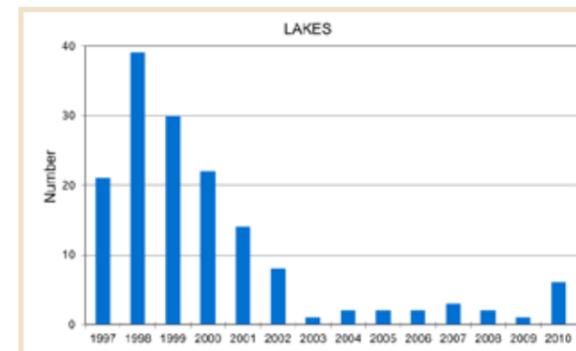
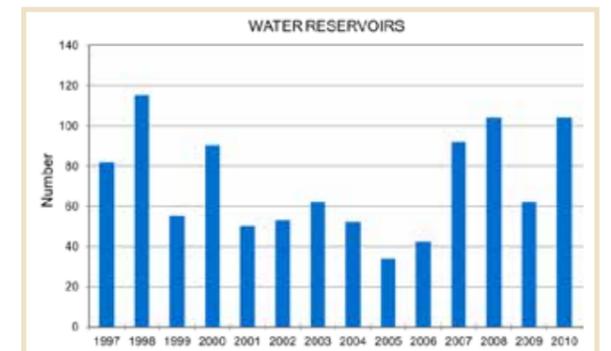
Fig. 16. The main structures constructed in 1997–2010 in the programme of small water retention (source: Kowalewski, 2013)

The number of reservoirs, and their water retention capacity is presented in Figures 16 and 17. Significant differentiation of objects constructed in the following years is clearly visible. The figures also indicate that there has been a reduction in the construction of damming devices. Moreover, the reservoirs constructed nowadays have a smaller water volume than the ones constructed in the past.

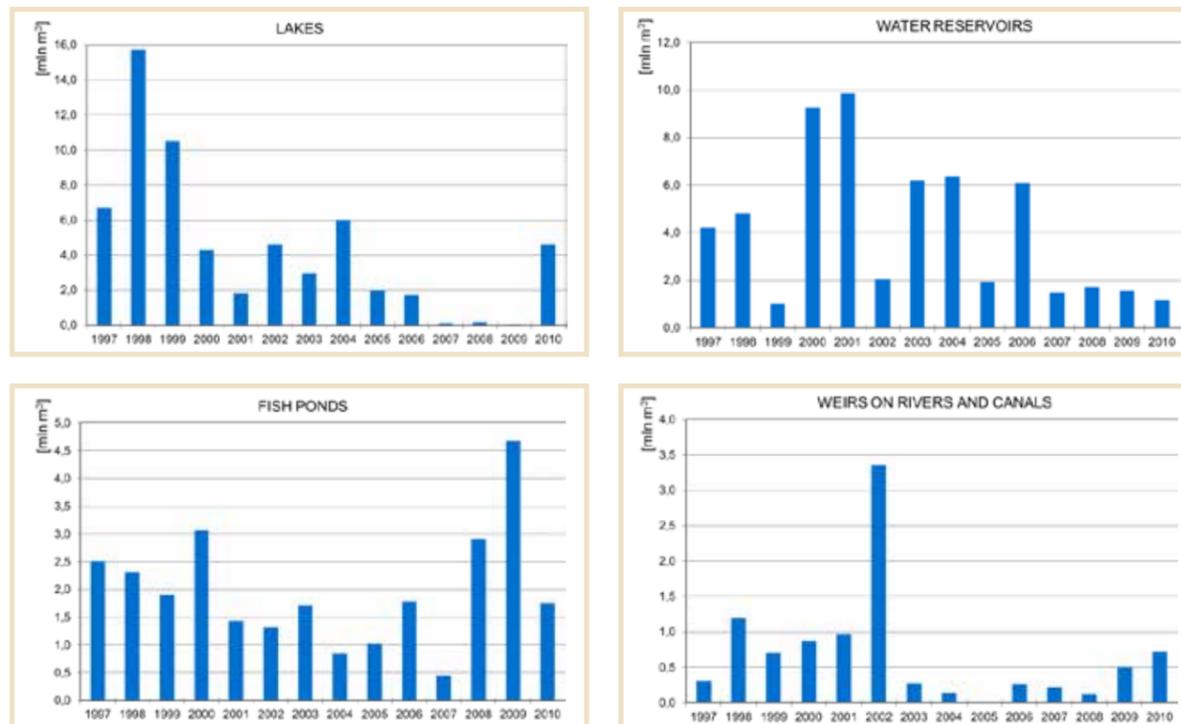
Fig. 17. Summary capacity of the main water retention objects constructed in 1997–2010 (source: Kowalewski, 2013)

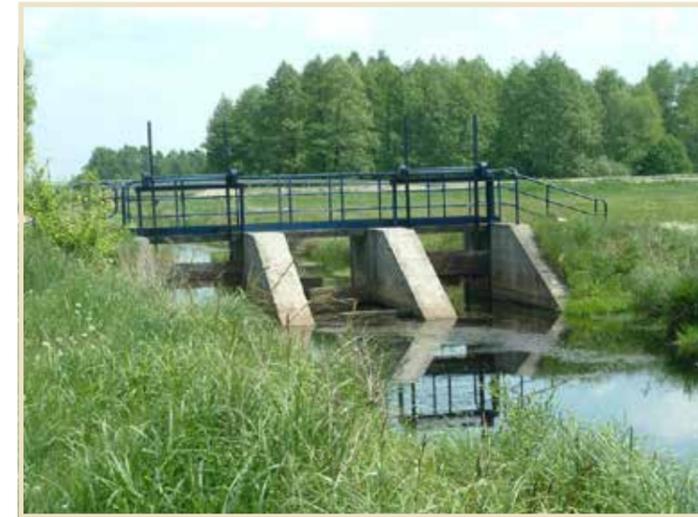
Photo 26. Hydraulic structure in the Kampinoski National Park – wetlands protection

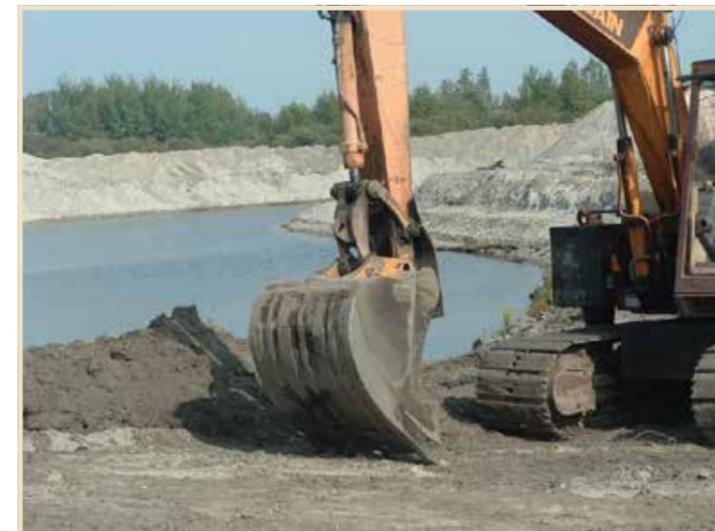
Photo 27. Construction of the reservoir in the river valley

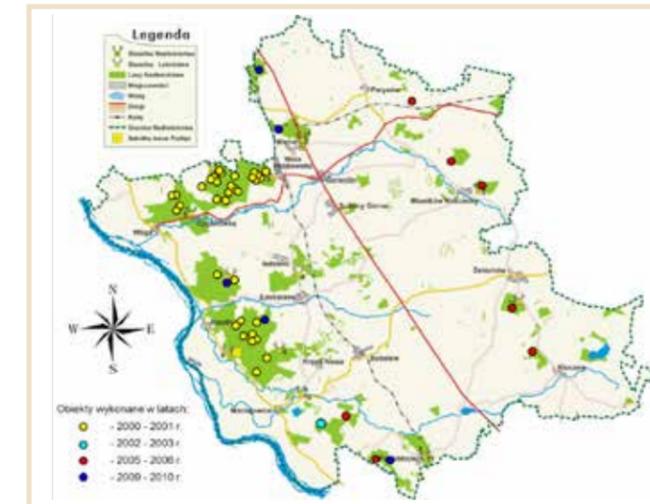
Fig. 18. Investments implemented within the project

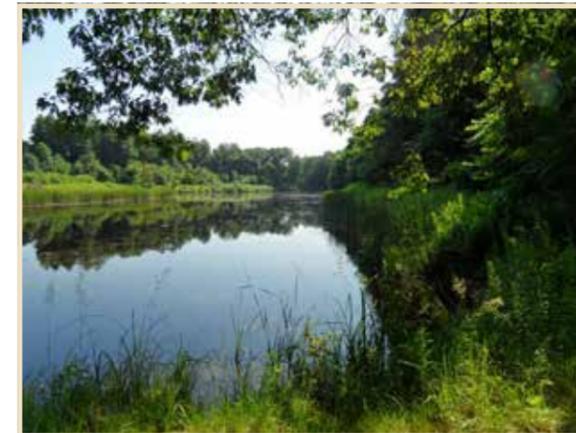
Photo 28. Retention reservoir
(photo by: W. Mioduszewski)

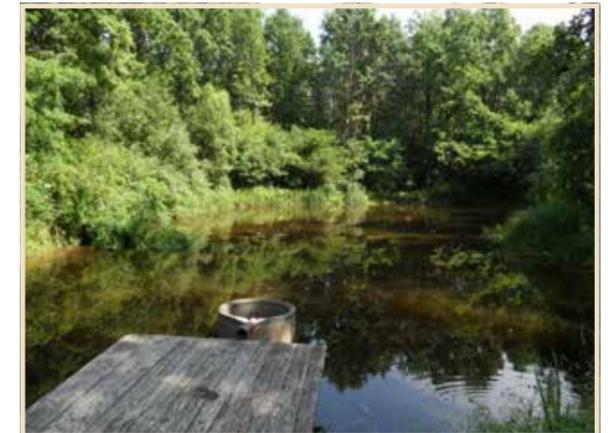
Photo 29. Water collection point
(photo by: W. Mioduszewski)

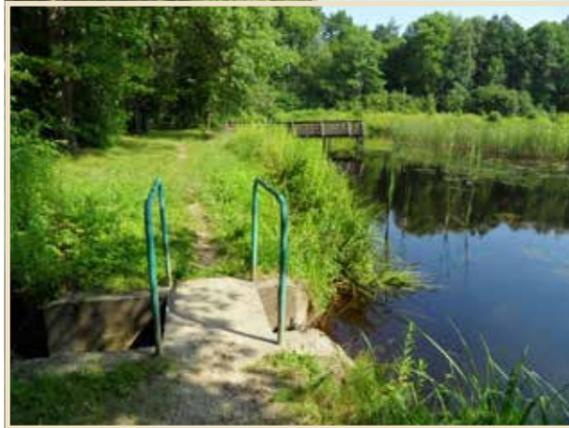
Photo 30. Damming device and viewing platform (photo by: W. Mioduszewski)

Special attention has been given to designing the damming valves in order to increase the biodiversity of forests, and improve habitats. This has been done by ensuring that slopes are not too steep, but still allow access to water for animals, creation of islands in reservoirs to serve as breeding sites for birds, and construction of irregular shaped shore line that create favourable conditions for amphibians breeding.

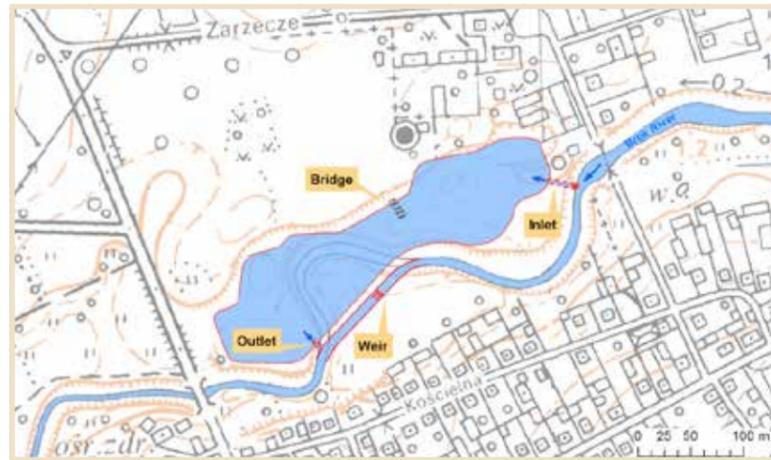
Fig. 19. Location of the investment on the previous course of the river

The reservoir is 40 000 m³ and the surface area is 2,45 ha. It has an average depth of 1,7 m. It has been constructed as an excavated reservoir, and it is situated beyond the present river bed (Fig. 19). Water flows to the reservoir after damming of the river by a gauge with a fish ladder (Photo 33). The damming level on a gauge is 1.2 m. The reservoir is filled in the spring when the water level in the river is high. During the summer, additional water is only added to make up for the transpiration loss or for irrigation. During the winter, the reservoir is empty, which allows it to obtain the maximum flood capacity.

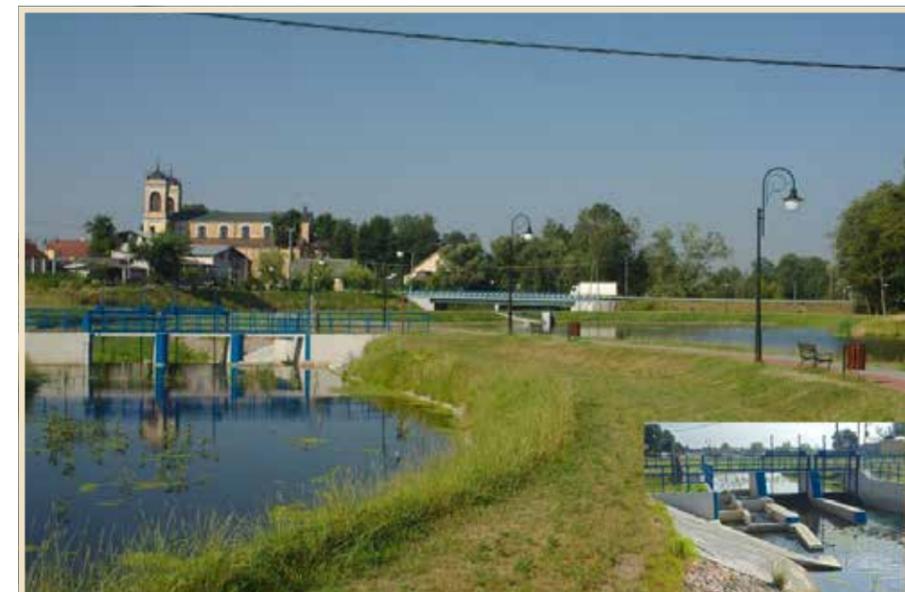
Photo 33. Damming device with fish pass (photo by: Łukasz Gajkowski)

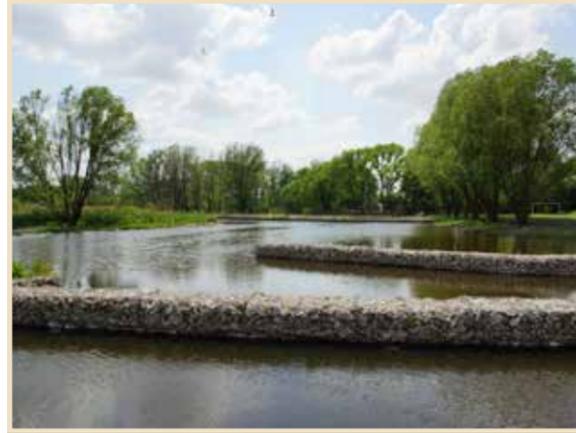
Photo 35. Northern part of Zgorzała Lake after restoration in spring 2014 – visible sedimentation ponds limited by gabions
(photo by: T. Stańczyk)
