Report on Water and Waste Assessment and its potential impact on the high altitude wetland along Druk-Path

30 June 2017

**Bhutan Water Partnership
Thimphu, Bhutan.**

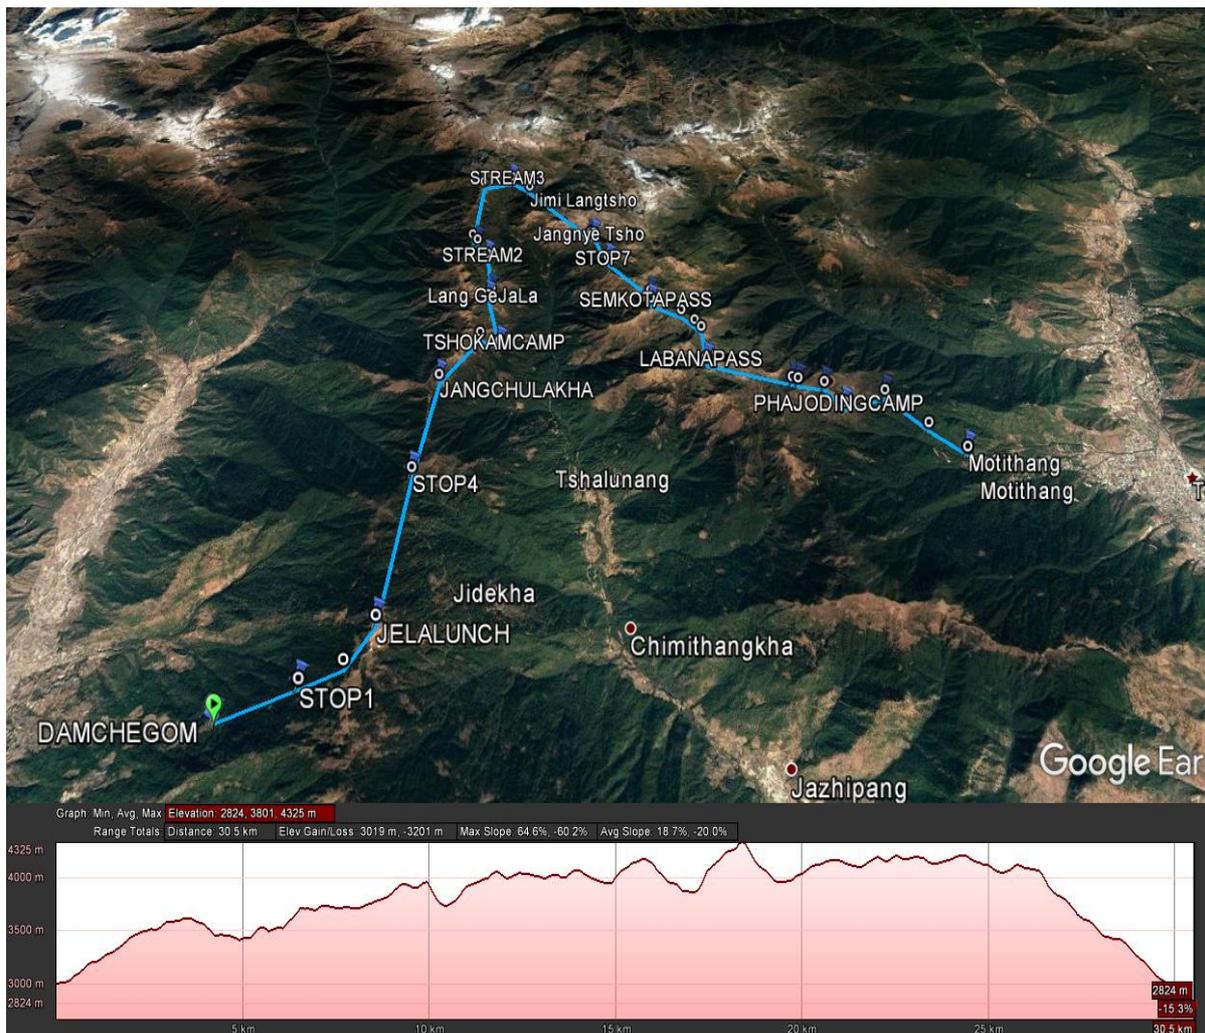
Figure 2: Trekking Route Information of the Assessment

Day One: Drive from Thimphu to *Damche Gom*, Hiked from *Damche Gom* to *Jele Dzong* for 3 hours. Continued hike to Jangchulakha campsite for 3 hours and further to the Tshokam campsite with additional of one hours walk.

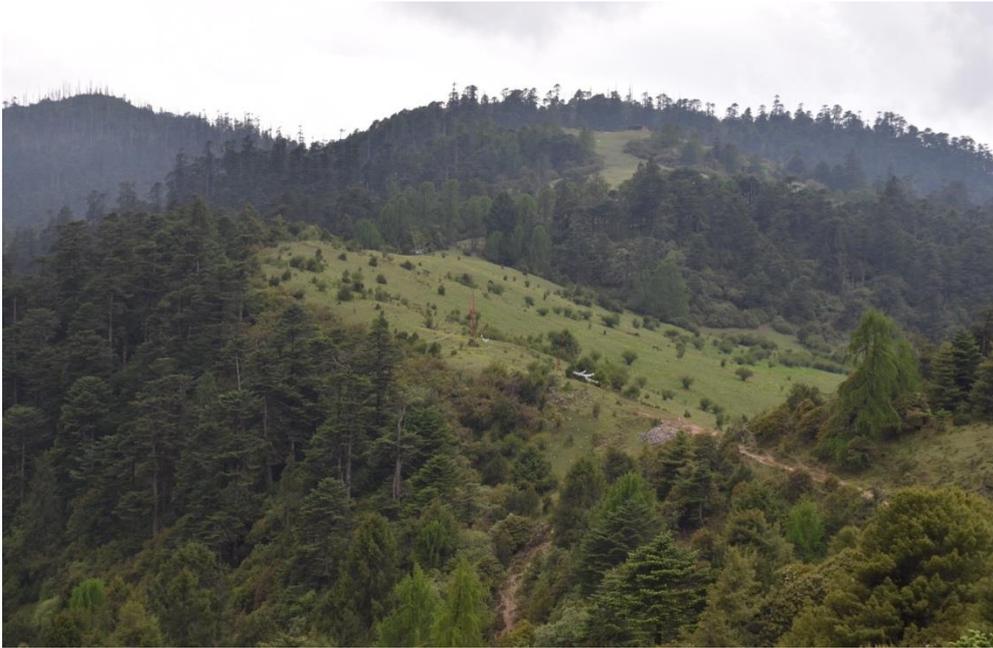
Figure 3: Forest Area along the Trekking Route

The dominant floristic type from *Damchoe Gom* to *Jelela* comprised of *Picea spinulosa* (Spruce), *Pinus wallichiana* (Blue pine) and *Tsuga dumosa* (Hemlock) around *Damchoe Gom* (2900 m a.s.l.). The mixed conifer forest slowly transit to *Abies densa* (Fir) forest before reaching (above 3000 m a.s.l.) *Jelela* (3500 m a.s.l.). The forest near the pass were found mainly composed of *Abies densa* mixed with *Juniperus recurva* (Juniper). The entire forest stretching from Museum to *Jelela* pass forms a part of the sub-basin of *Dochhu*. The stream that originates from the *Jelela* watershed caters to the communities of *Dopshari* and *Humrel Geogs*¹ for drinking and irrigation purposes.

There are logging activities along the Damchoe Gom route, which is an important watershed area. The team strongly recommended for the conservation of this critical watershed and control illegal felling of trees. However, besides some illegal felling, the forest is still in good condition and may need to protect form further disturbances in future.

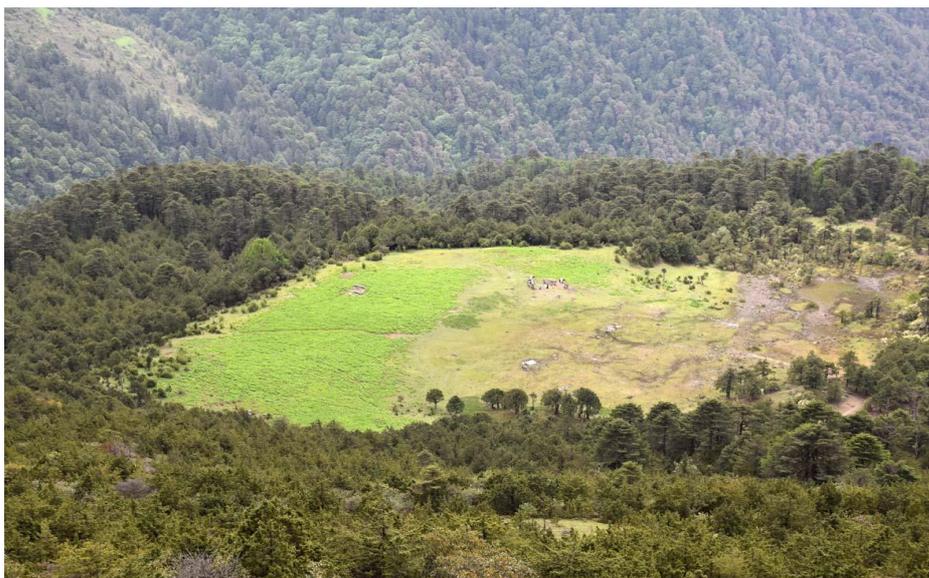
Figure 4: Camping Site at Tso-Kam

Day Two: Hiked from *Tshokam* almost vertically to a ridge called *Lang ge Gela* with a brake on its way where the team reached to *Jimi Langtsho* after five hours of hiking. Another two hours of hike took the tem to *Ja Nyel Tsho Campe* site. Tsokam camp site (3665 m a.s.l.) was located on the small depression (recharging flat wetland) dominated by *Rumex nepalensis* indicating degradation of wetland mainly brought about by cattle (winter Yak and summer local cattle) grazing and also the site serves as cattle shed. Floristically, the *Tsokam* cattle shed site was surrounded by mainly *Juniperus recurva*, *Abies densa*, *Rhododendron campylocarpum* and *Larix griffithiana*. The photo depicts a typical high altitude coniferous forest. A small spring was observed below Tsokam (seasonal lake) where the herders and trekkers make use of the water for drinking and washing. The team tested the spring water quality using instantaneous measurement kits (pH, turbidity, CO).

Based on the geographical land formation, the Tsokam site is an important collection or recharging site during the monsoon rain (June-September) and probably a perennial spring or stream discharges down below. Thus, the area appears as wetland and an important source of spring water during the lean season.

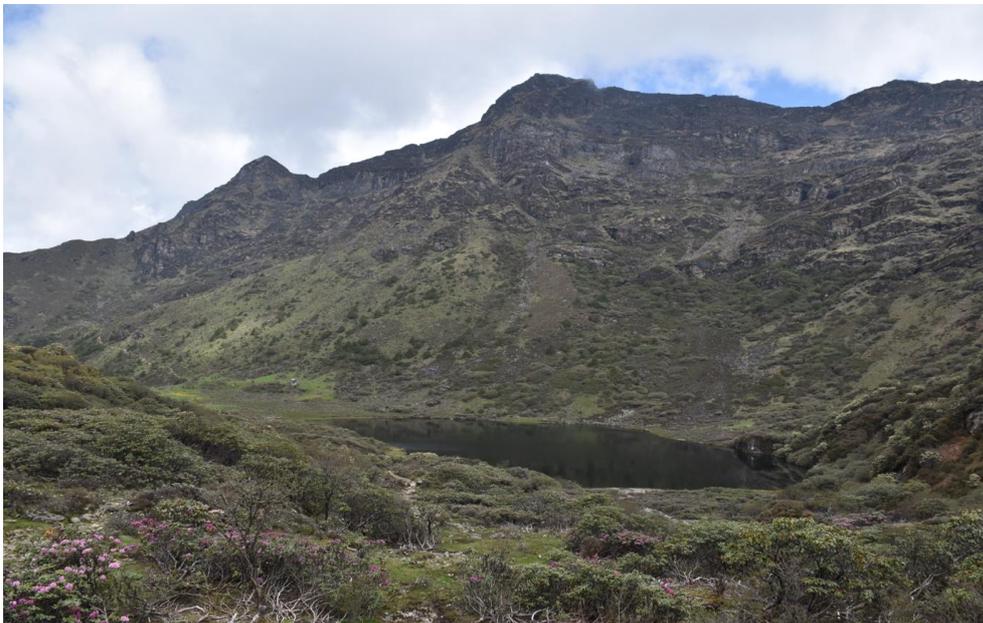
Figure 5: Camping Site at Bja-Ney

Day Three: The Bja-nye Tso is located at 3845 m.a.s.l. On the third day, we trekked from Bja-nye Tso to Semkota Lake, then to Labana and eventually to Phajoding campsite. Total hike duration was about eight hours.

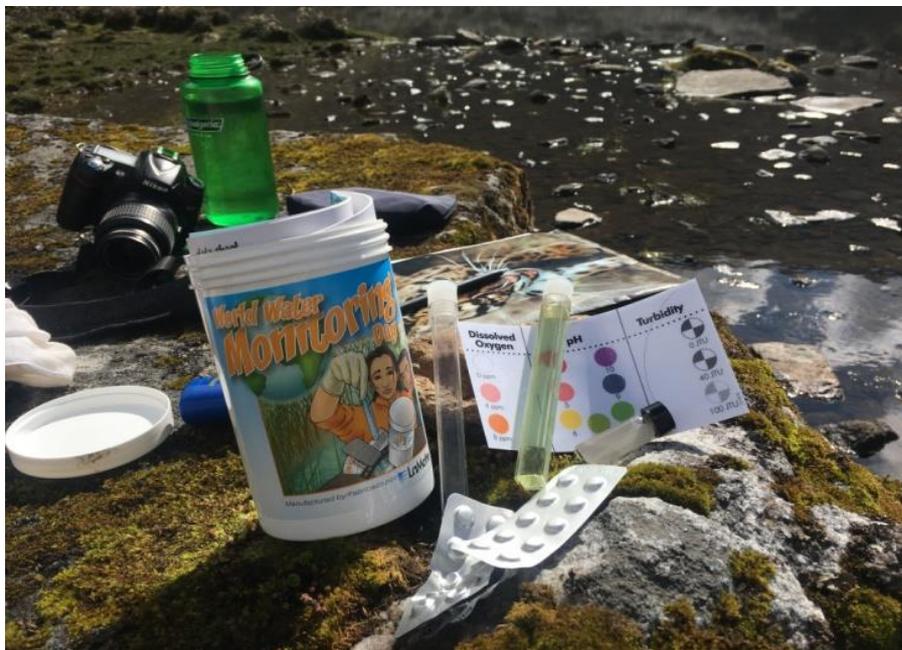
Figure 7: Water Quality Testing Kit

The water quality assessment was carried out to determine Temperature, pH, Turbidity, and DO using the Basic Test Kit from World Water Monitoring Day Kit of Earth Echo International². Additionally, the streams and outlets of lakes were identified with the help of handheld GPS, and volumetric measurements carried out using float methods. General observations of the forest ecology, watershed and bio-diversity were also made by the team visually.

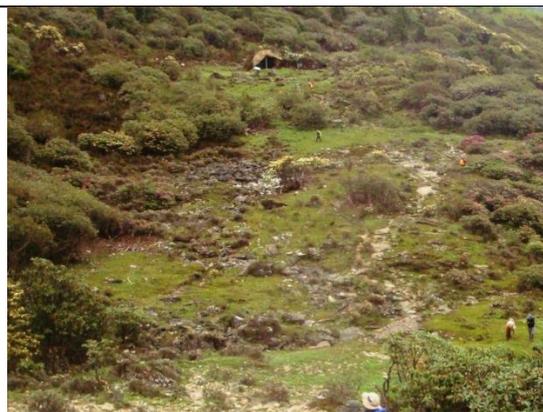
Stream	Latitude	Longitude	Elev.	Date	Discharge (l/s)	Landmark
Stream 1	27.51606	89.49706	3994	6/9/2017	0.0314	After Lang Ge Je la Pass
Stream 2	27.52541	89.4952	3992	6/9/2017	0.3619	Plateau
Stream 3	27.54886	89.49904	3930	6/9/2017	1.5022	Before Jimi Langtsho
Jimi Langtsho	27.54563	89.50374	3869	6/9/2017	284.9771	OUTLET
Jan Nygel Tsho	27.53147	89.52021	3920	6/10/2017	23.67953	Outlet

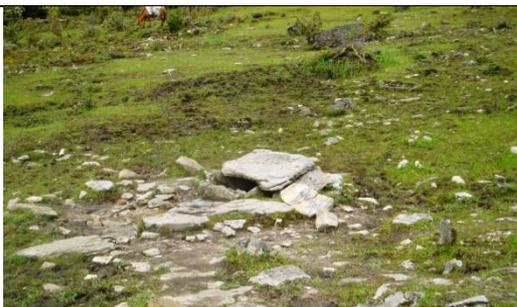
Spring water at Tshokam Camp

Location/Date	Time	Temperature (Celsius)	PH	DO	Turbidity (JTU)	Altitude
1. TsoKam/9/6/17	8:00 am	8 degree	6.5	0	0	3,700 m
2. Jigmelangtsho 9/6/17	4:49 pm	8 degree	7	0	0	3,869 m
2. Bja-Ney Tso 10/6/17	8:00 am	10 degree	7	0	0	3,920 m
