# A Comprehensive Study on the Use of Solar Based Drinking Water Supply and Solar Irrigation Pump in Bangladesh

March 2019

Prepared by  
CEGIS for Bangladesh Water Partnership (BWP)

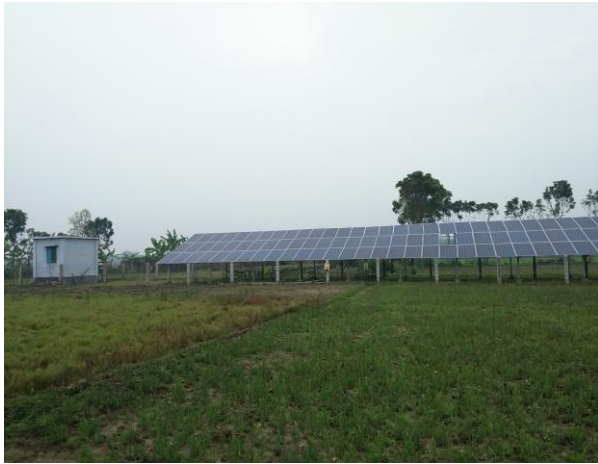
**Photo 1: Solar Irrigation Pump (SIP) in Doyapur of Kaliganj, Jhenaidah**

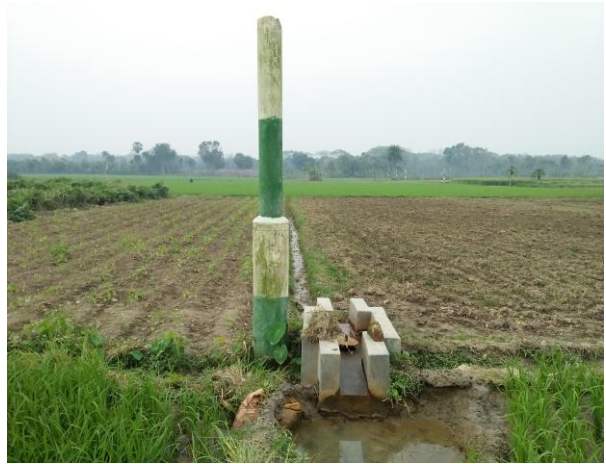
- The underground based water-pipe for irrigation means that there is more land for cultivation as the land used for drainage in the past is now cultivable.

- The farmers were also happy with the water pressure in comparison to diesel operated pumps. The service operator (lessee) claimed that the water pressure is maintained with air outlet at several intervals that ejects any air pockets created within the pipes which would otherwise drop the water pressure inside the pipe.

**Photo 2: Supply line of Solar Irrigation Pump (SIP) in Doyapur of Kaliganj, Jhenaidah**

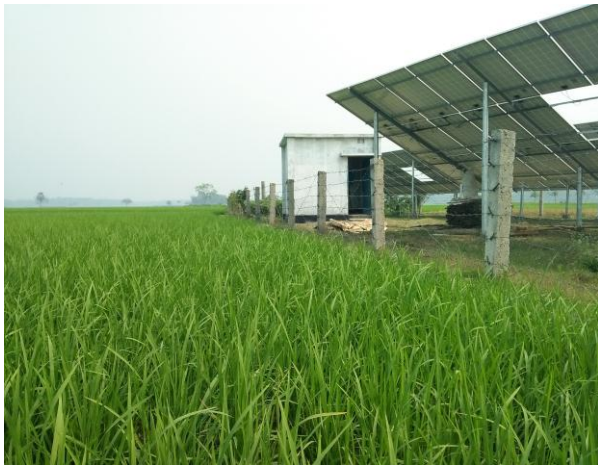
**Photo 3: Solar Irrigation Pump (SIP) in Jagannathpur of Kaliganj, Jhenaidah**

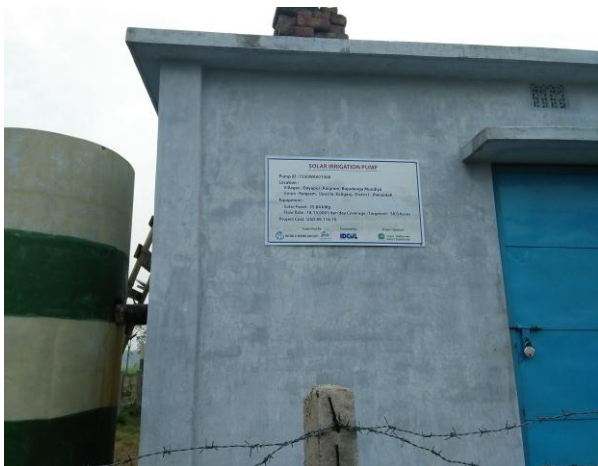
- The installed capacity of the solar panels (119 standard panels) is 38,080V DC, 18.5kW which is then inverted to 620V AC to operate a 25HP<sup>3</sup> induction motor.

- The motor is optimized to operate at 3000 rpm<sup>4</sup> under normal conditions. The motor is connected to the vertical shaft of a centrifugal pump.

**Photo 5: Solar Irrigation Pump (SIP) controller, motor and connector panel housing in Doyapur of Kaliganj, Jhenaidah**

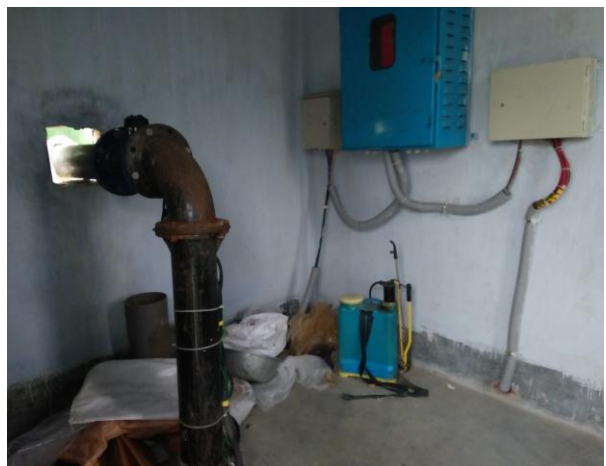
**Photo 6: Inside of the controller, motor and connector panel housing in Doyapur of Kaliganj, Jhenaidah**

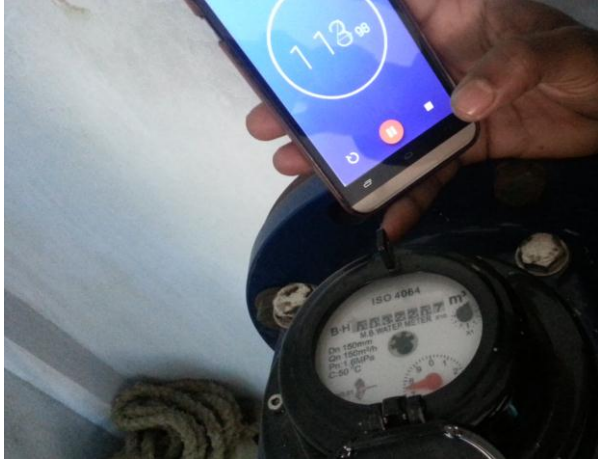
- These pumps are capable of drawing 96 litres of water per second. Under normal operation, they draw around 85-86 litres of water per second on average. The operators of the SIPs also showed the pumps in operation and the above information was verified by the study team.

**Photo 7: SIP performance verification through measurement in Doyapur SIP, Kaliganj, Jhenaidah**

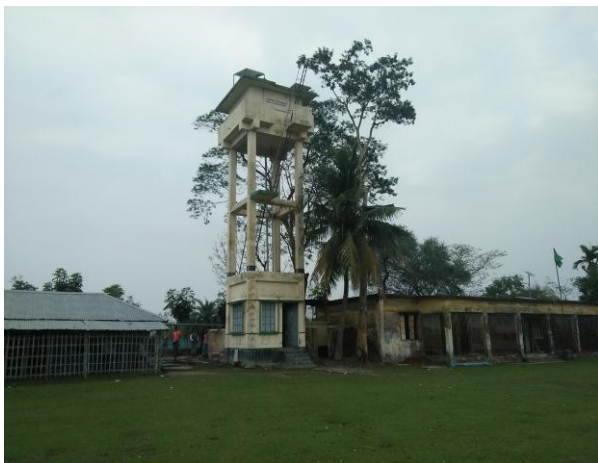
**Photo 11: Solar Based Drinking Water Supply (Solar DWS) in Darunmallik of Paikgachha, Khulna**

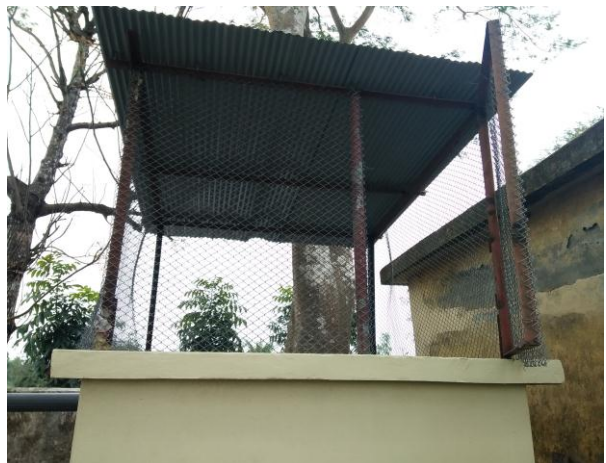
**2.10 Arsenic Solution:** BRAC WASH has found that the groundwater contains arsenic in it. The measured level was 0.062 mg/L<sup>7</sup> (Source: BRAC WASH Laboratory Test – See **Annex-II, Lab Results 1.1**) which is slightly higher than 0.05 mg/L – the level set by the Department of Environment (DoE) of the Government of Bangladesh. BRAC WASH has found a solution to bring the arsenic contamination below the standard level by implementing a filtering process. The field study team found that the filter has already been constructed adjacent to the Solar DWS water tank. The filter will store rainwater, filter it through several levels of gravels, sands and other filtering materials by stages and then will get mixed with the groundwater through a 36.6m (120 ft.) boring to bring the contamination level below the set level. The field study team has been advised that the filter will start operating as soon as it starts accumulating more rainwater.

**Photo 12: Provision for arsenic contamination reduction in Darunmallik of Paikgachha, Khulna**

- Presently, the dire need is to remove the fear of arsenic contamination from the current and prospective users by fast implementation of the filter system in place.
- One of the complains was that the users found dirt in the water supplied by the Solar DWS. Appropriate measures should be taken such as there is no dirt found in the water. Chlorine injection to kill moss grown and filtering the water at least once a month will need to be carried out;
- Another complain is the typical thinking that water drunk from pipeline results in gastric. For

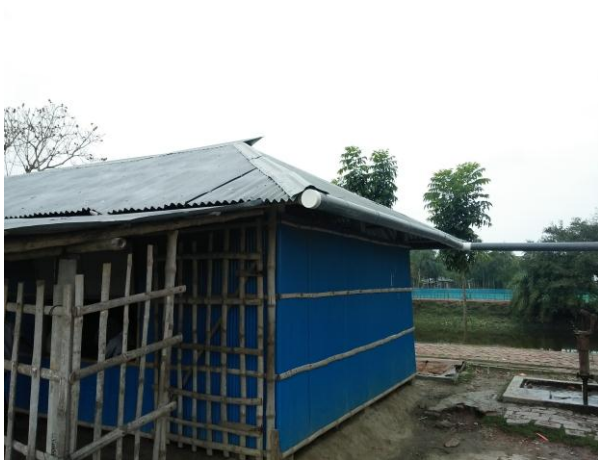
**Photo 15: Rainwater collection using pipes and rooftop in Darunmallik of Paikgachha, Khulna**

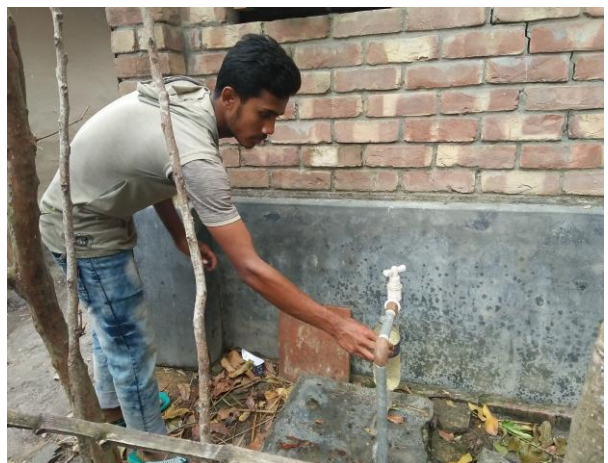
As expected, the salinity of the Solar DWS sample (Sample 2, Annex-II: Lab Results 1.2) is found to be 1.24 ppt<sup>8</sup>, much lower than the nearby separate source of groundwater sample (Sample 1, Annex-II:

Lab Results 1.2) at 2.14 ppt. For comparison purpose, the average freshwater salinity is 0.5 ppt or lower. The results are also found in favour of the Solar DWS sample as it has lower turbidity and lower concentrations of total dissolved solid (TDS), Nitrate (NO<sub>3</sub>) and Iron (Fe) compared to the nearby groundwater sample.

**Photo 18: Water sample collection from Solar DWS in Darunmallik of Paikgachha, Khulna**
