Bhutan Water Partnership

Assessment Report

Effluent Discharge and Management by Automobile Workshops in Paro Municipal Area; Bhutan

November, 2017

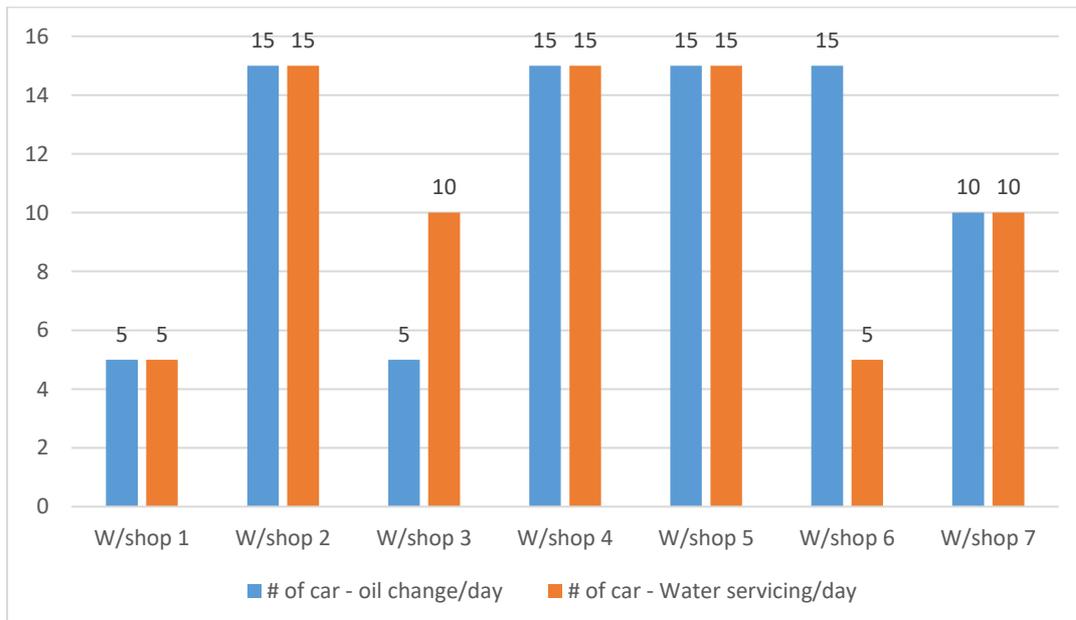
Figure 2: Number of Car Wash & Oil Change per day per workshop

The figure 2 below shows that the lowest number of cars coming for water servicing is five cars per day and for engine oil change it is 5 cars per day. Similarly, the maximum number for cars that come for engine oil change per day is 15 and for water servicing 15 cars per day is the maximum.

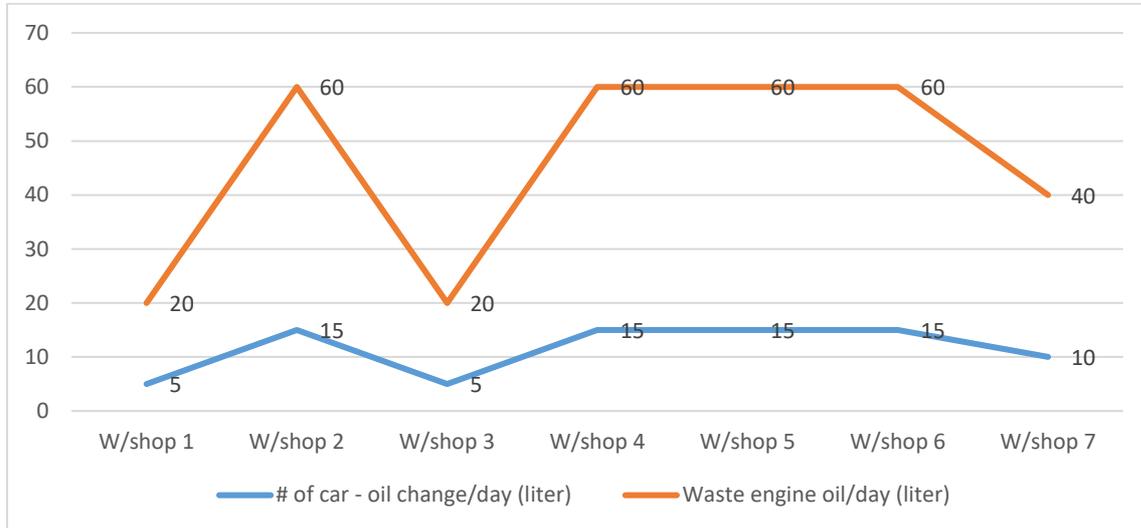
Figure 3: Automobile Workshops Generating Waste Oil, Per Day

As indicated in the above figure (3), the maximum waste engine oil generated by an automobile workshop per day is around 20 liters. The maximum waste engine oil generated by an automobile workshop in a day is around 60 liters.

Although, during the focus group discussion and also questionnaire interview, it was reported that the engine oil is collected in a large container and sold to the neighboring country, there are evidences of spillage of these oil on the ground. It is assumed that most of the spillage flow out in to the water bodies or contaminates the soil.

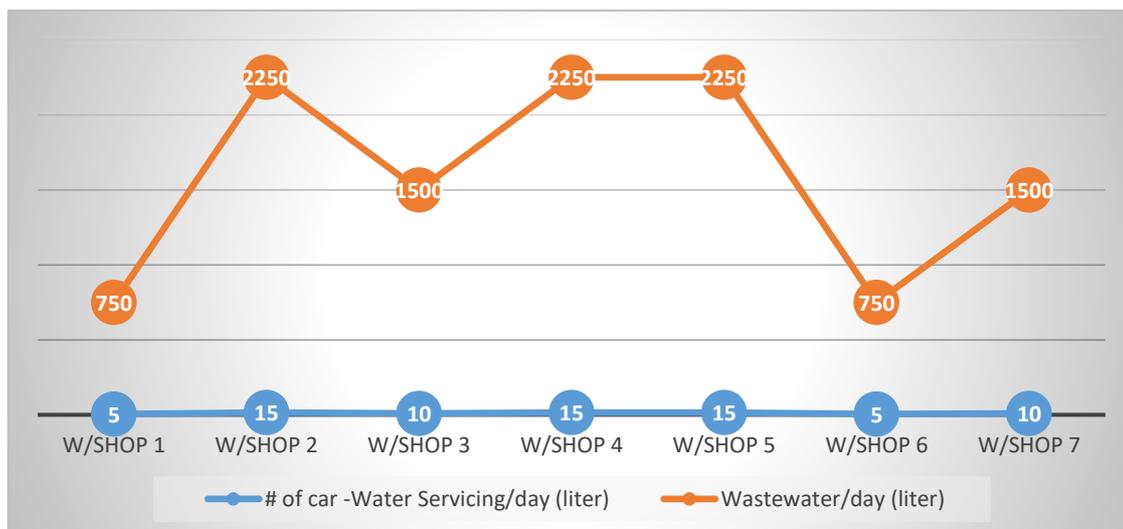
Figure 4: Automobile Workshops Generating Wastewater Per Day

In terms of the wastewater generated from the water servicing of vehicle, the lowest amount of wastewater is 750 liters per day and highest is 2250 liters of wastewater per day. During the focus group discussion, most of the automobile workshop owners reported to having sedimentation tanks, during the observation, only three workshops had sedimentation tanks. Most of the wastewater seems to flow into the waterbodies.

It was observed that, there is no oil & grease separator and effluent treatment plants, thus, the Dzongkhag/Municipal Office and the workshop owners should look into installing such facilities before it is too late.

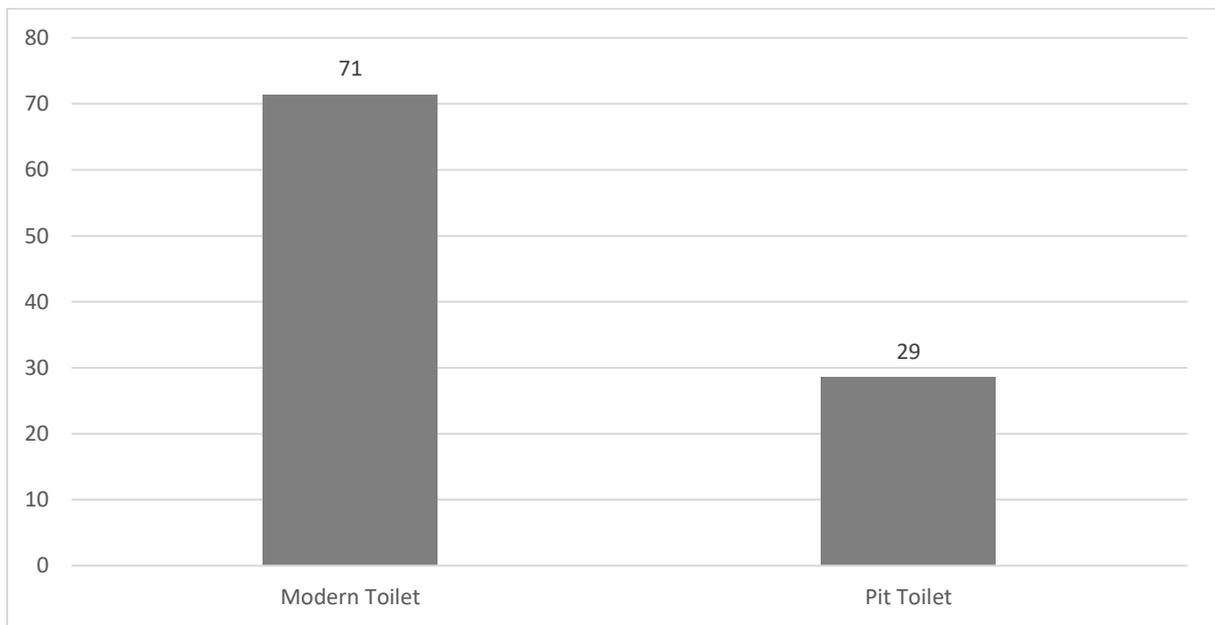
Figure 5: Automobile Workshops with Modern and Pit Toilets

To prevent open defecation and urination, all workshops should have modern toilet. However, from the eight workshops assessed only 71 percent of the workshop had modern toilet and 29 percent of the workshop did not have modern toilet.

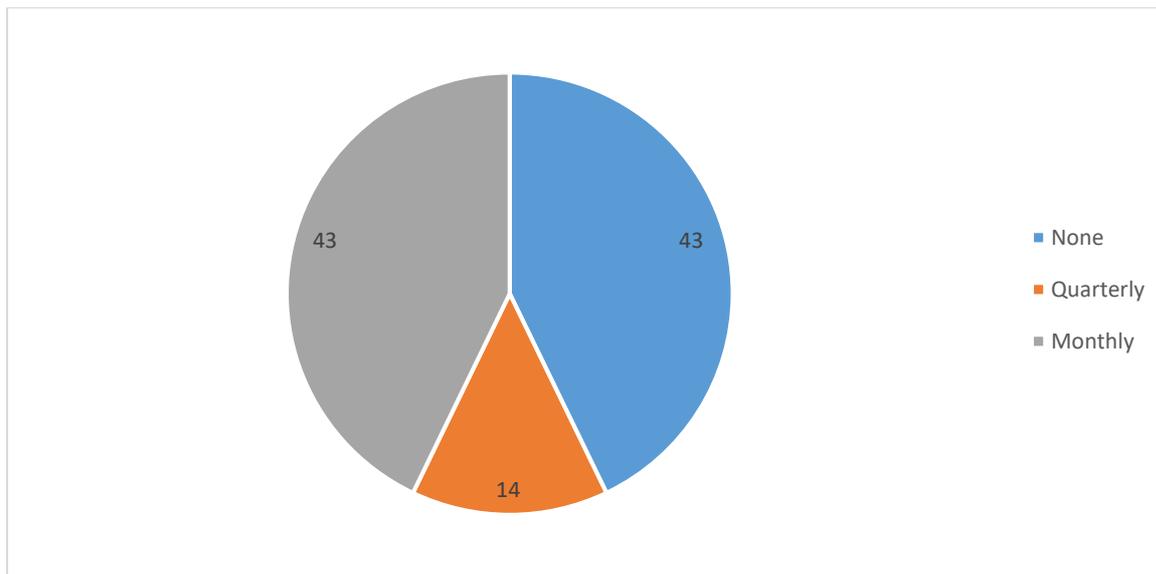
Figure 6: Frequency of Monitoring Effluent Discharge by Automobile Workshop Management (in %)

It was reported at that focus group discussion, that the automobile workshop owners did not have an elaborate system of effluent quality monitoring. Their effluent quality monitoring entailed, waste and garbage clean-up activities of establishment and some level of awareness about effluent discharge among the mechanics and their staff. 43 percent of the automobile workshop owners conducted clean-up activities on a monthly basis and 14 percent of them conducted such activity on a quarterly basis. However, 43 percent of the automobile workshop owners did not initiate any clean-up activity.

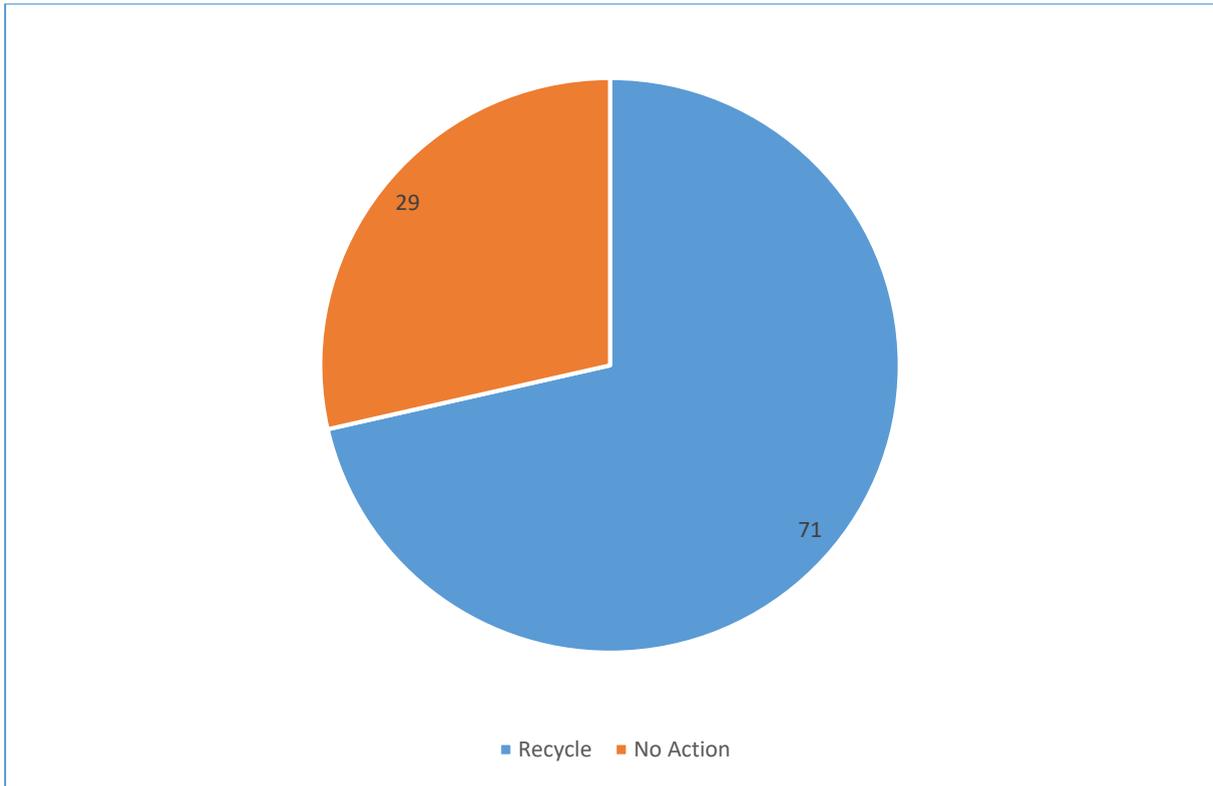
Figure 7: Waste Vehicle Battery Recycled and No Action (in Percentage)

The workshop owners were also asked about the waste vehicle battery and 71% of the respondent said that they recycle the old batteries and 29% of the workshop owners said that they don't take any action with the old batteries.
