**Disaster Risks in Ayeyarwady Delta,  
Irrigation and Flood Protection.**

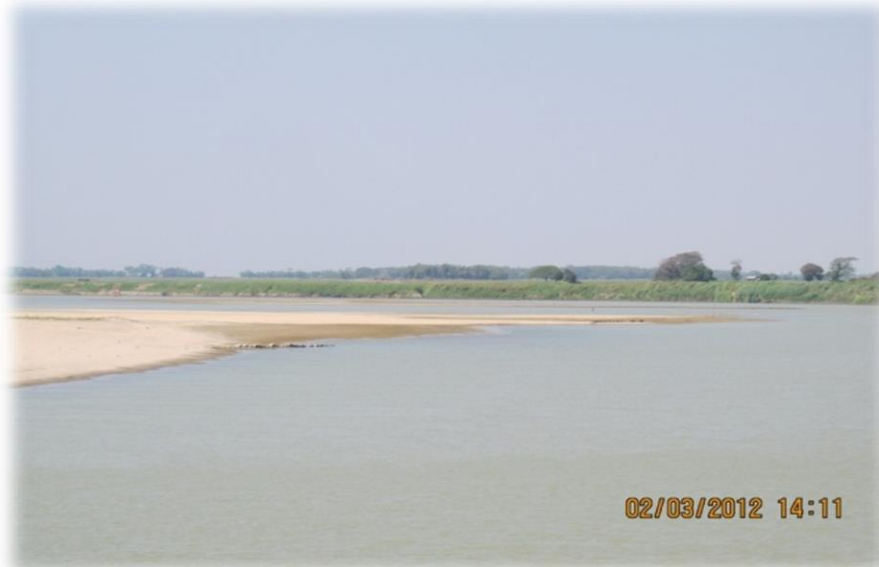
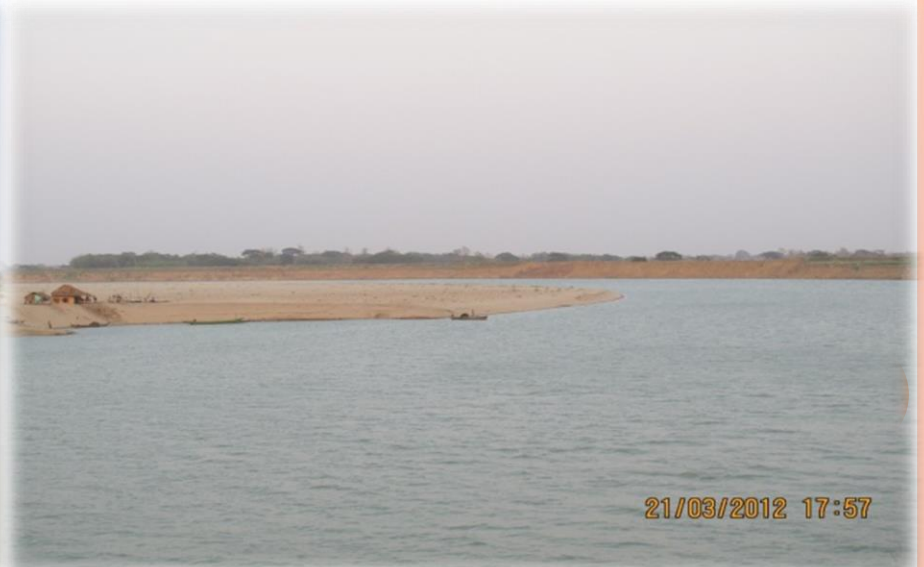
# Sedimentation

- ❖ Rivers are active with bank erosion, emergence of sand bars progressively high
- ❖ increase suspended load (Deforestation , Gold/ mineral/ Gem and precious stone extractions, Dam and storage reservoir construction)
- ❖ Bridge construction and other development activities obstruct the river flow, that process instigate the sediment deposition in the lower delta.
- ❖ Changes of river flow pattern by the climate change impact comes high sedimentation and make worse the river deterioration .

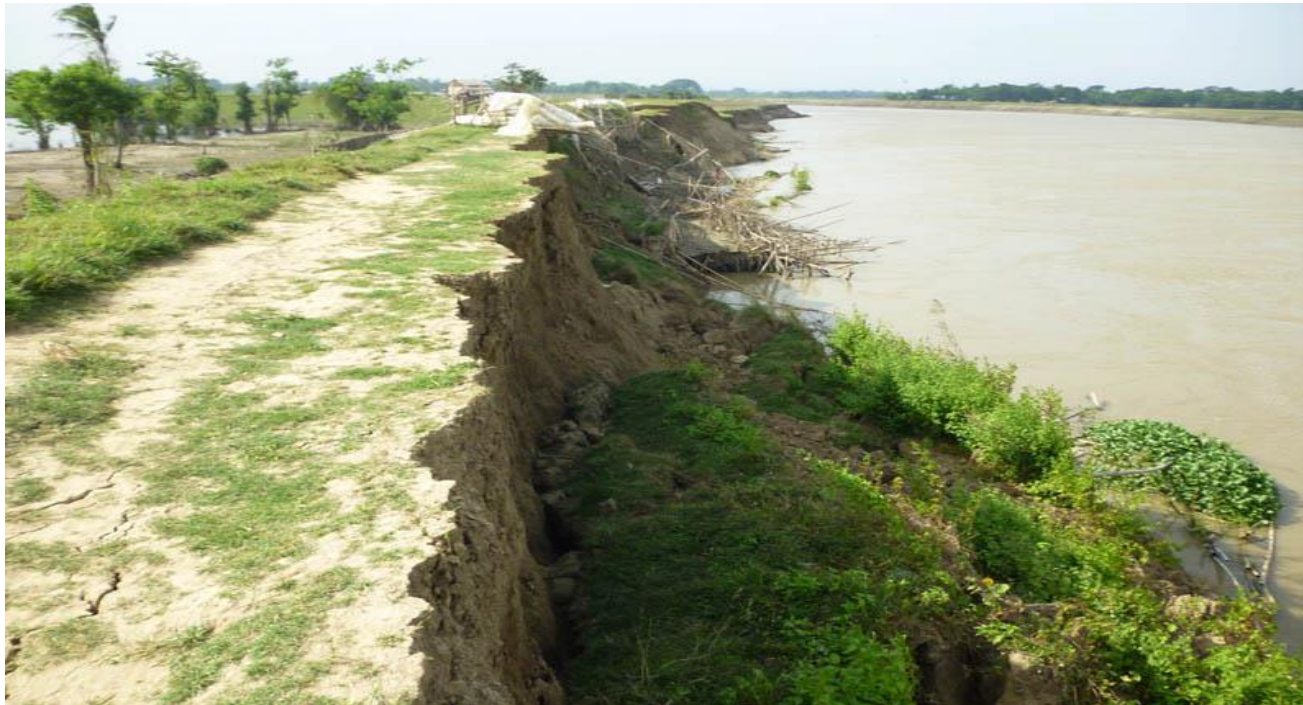
## River Bank and Coastal Erosion

- ❖ One of the major issues, many places along the upper delta.
- ❖ River geo-morphology is very dynamic
- ❖ Mangrove destruction ( shrimp ponds, reclamation for cultivations, migrant of fishermen communities, firewood collection and charcoal production )

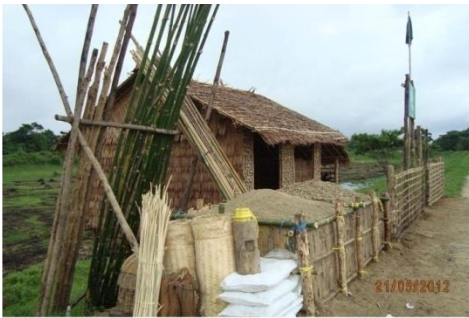
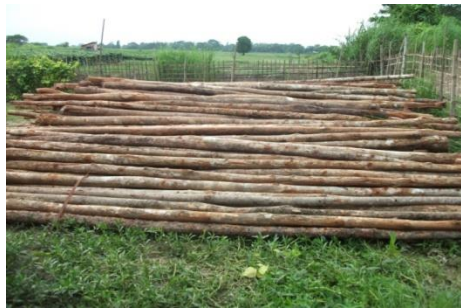
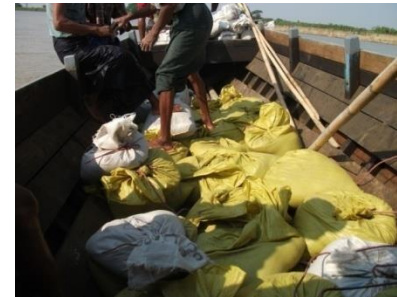
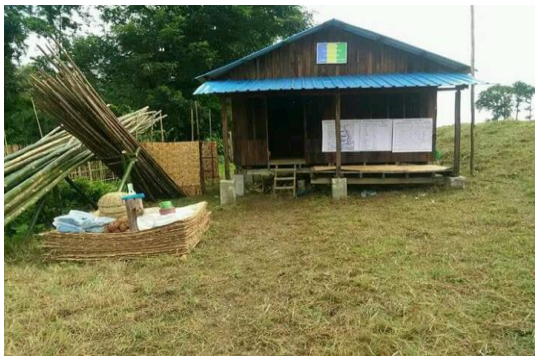
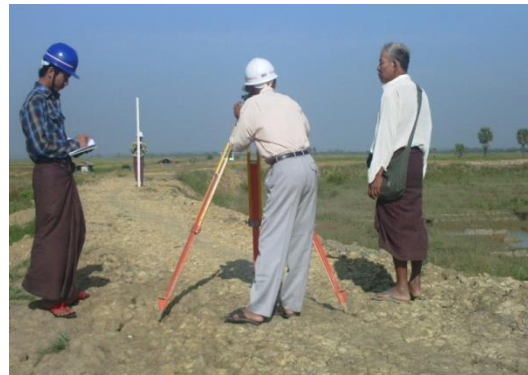
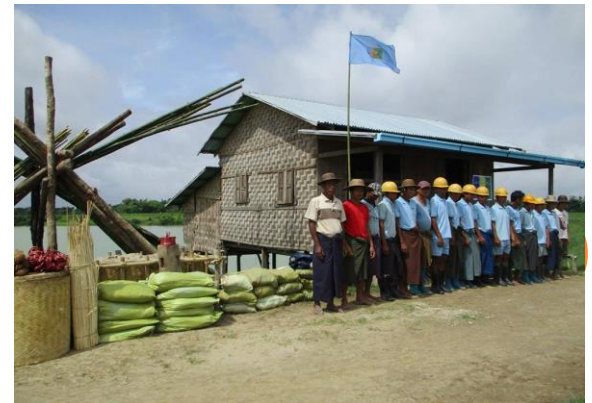
## Maintenance and Care of Dykes

- ❖ Regular inspection along the dikes conducted by embankment officer
- ❖ Clearing bushes and shrubs growing on the slope of the dike and the toe
- ❖ Treatment of Leak holes due to rodents, termites, insect and some reptiles etc...
- ❖ Investigation of LS & CS of dyke, bank offset measurements
- ❖ Ordinary maintenance and Special repairs of dykes, new dyke( retirement) established where necessary.
- ❖ emergency materials are collected at the patrol camps located every 4 miles each.
- ❖ providing wireless network or mobile phone communication system
- ❖ On foot patrol in the respective jurisdiction before 1 foot to meet danger water level.

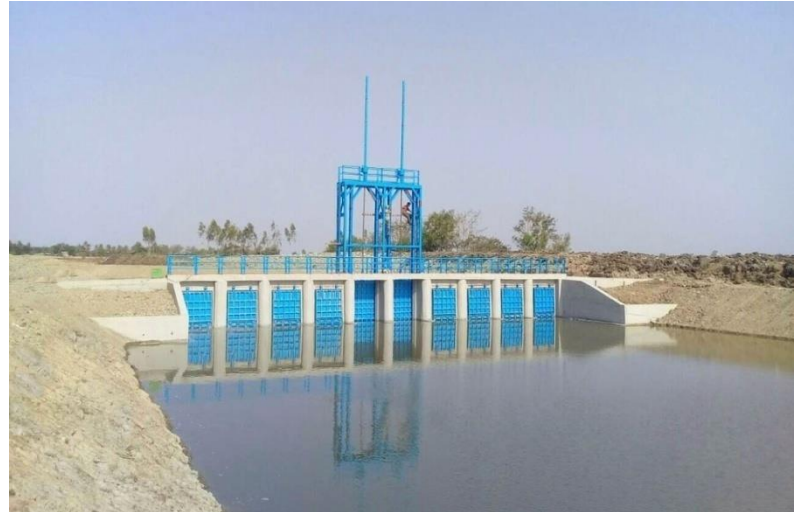
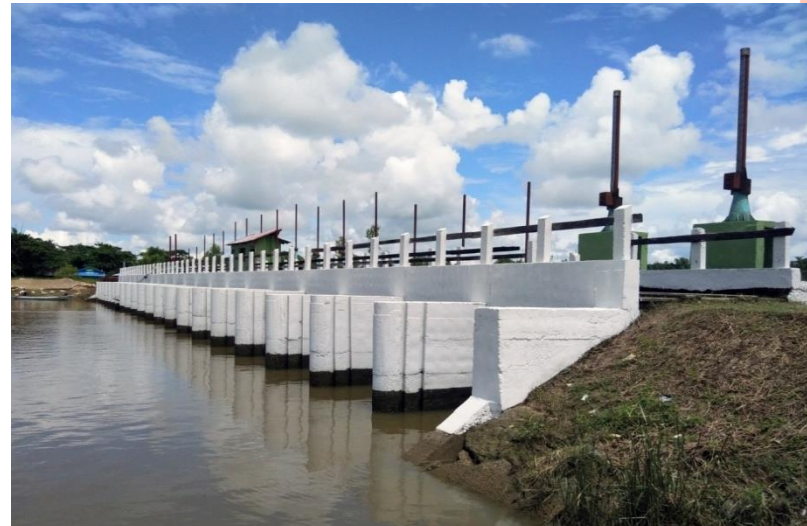
# ဖျာပုံမြို့နယ်၊ ကြက်ဖမွေးစောင်းကျွန်းပတ်တာ

(စကေး၊ ၁လက်မ = ၄၀၀၀ ပေ)

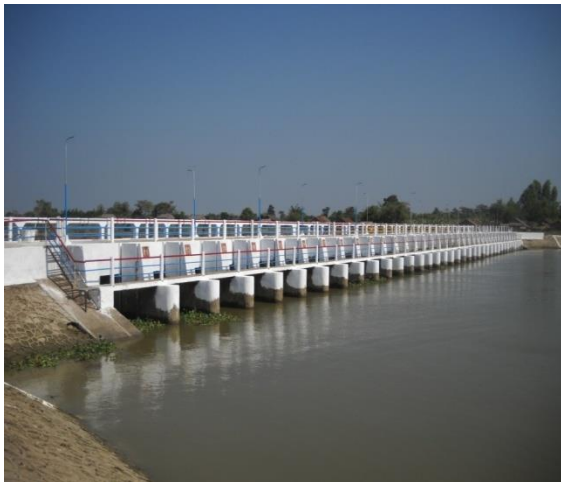
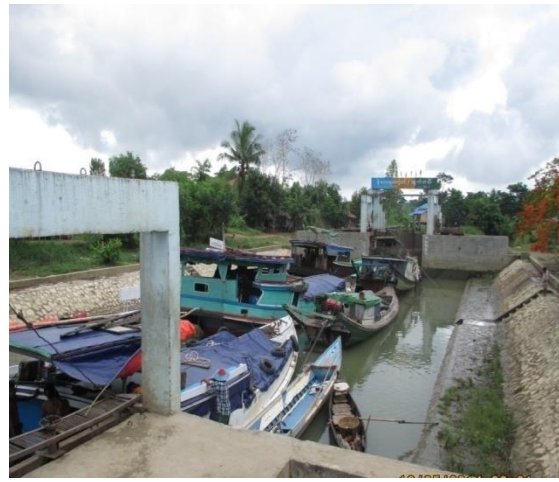
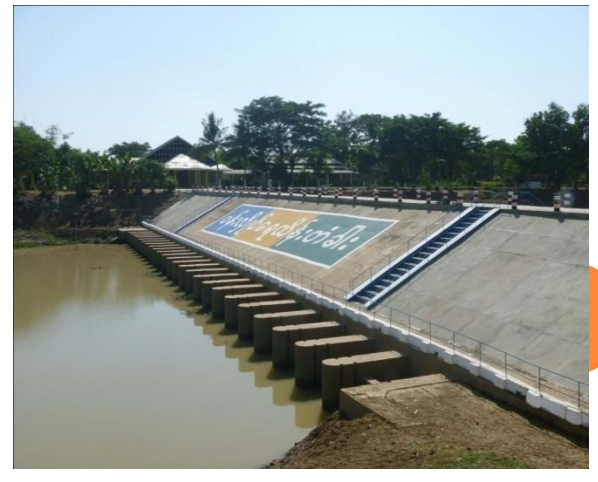
## Present Issues

- ❖ Sea level rise
- ❖ Intensive Rainfall in the polders
- ❖ Deposition of sediment in out-fall channels in dry season ( $\approx 1$  m )
- ❖ Widespread inundation in the polder (rainy season)
- ❖ Restriction of budget allotments
- ❖ Suitable machine deficiencies
- ❖ Level of acidity in the soil comes high
- ❖ Natural channels or creeks need to be dredged up
- ❖ Polder facilities such as dyke, sluices and drainage canals also need to be rehabilitated.
